# Access Compliance Report

## Public Rights-of-Way

### (Curb Ramps)

Intersection ID: 47999		Main Street: REDBRIDGE_TL		Cross Street: CLYMER_CT		Location: NE			
ADA ID: BC77F7F94A53		Ramp Type: PerpDiag		Initial Pass/Fail: Fail		Overall Compliance: No		Severity Score: 22.5	
Codes/Mitigation Info/Possible Solution					Field Measurements/Component Compliance

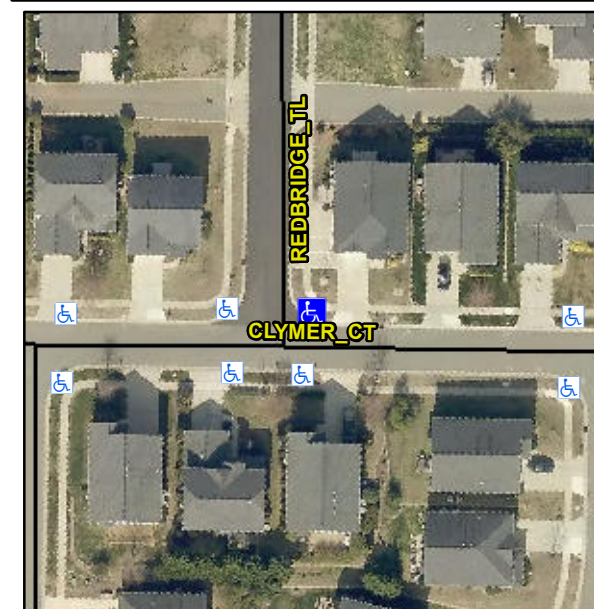
**Not Found, R304.5.1, R304.2.2, R304.5.3**

Compliance	Description	Data	Compliance	Description	Data
N/A	Ramp Length (in)	71.5	No	Ramp Slope (%)	9.2
No	Ramp Width (in)	47.0	No	Ramp XSlope (%)	4.2
N/A	Flare Type LT	N/A	N/A	Flare Type RT	N/A
N/A	Flare Slope LT (%)	N/A	N/A	Flare Slope RT (%)	N/A
N/A	Flare Traversable LT?	N/A	N/A	Flare Traversable RT?	N/A
N/A	Landing Length (in)	N/A	N/A	DWS Provided?	N/A
N/A	Landing Width (in)	N/A	N/A	DWS Contrast?	N/A
N/A	Landing Slope (%)	N/A	N/A	DWS Length (in)	N/A
N/A	Landing X Slope (%)	N/A	N/A	DWS Full Width?	N/A
N/A	Landing Curb? (Y/N)	N/A	N/A	DWS Offset (in)	N/A
N/A	Shared Landing?	N/A			
N/A	Gutter Ponding?	N/A	N/A	Gutter Slope (%)	N/A
N/A	Gutter Lip Ht (in)	N/A	N/A	Gutter X Slope (%)	N/A
N/A	Painted X Walk1?	No	N/A	Painted X Walk2?	No
	X Walk 1 Direction	To W		X Walk 2 Direction	To S
N/A	X Walk 1 Width (in)	N/A	N/A	X Walk 2 Width (in)	N/A
	X Walk 1 Slope (%)	3.5		X Walk 2 Slope (%)	0.7
	X Walk 1 X Slope (%)	1.6		X Walk 2 X Slope (%)	4.5

N/A	Ramp inside XWalk1?	N/A	N/A	Ramp inside XWalk2?	N/A
	Road Slope (%)	5.3	N/A	Clear Space?	N/A
	Road X Slope (%)	0.8	N/A	Clear Space to XWalk (in)	N/A
N/A	Any Obstructions?	N/A	N/A	Storm Grate/Utility Hazard?	N/A
	Obstruction Type			Storm Grate/Utility Type	
		N/A			N/A
			Yes	Surface Condition? (G/P)	Good

**Remove & Replace Curb Ramp With Two New Directional Ramps or Equivalent.**
