Intersection ID: 31463	Main Street: COBDEN_LN	Cross Street: HARLAND_ST	Location:	NE
ADA ID: BC832331FAF3	Ramp Type: PerpDiag	Initial Pass/Fail: Fail	Overall Compliance: No	Severity Score: 26.25

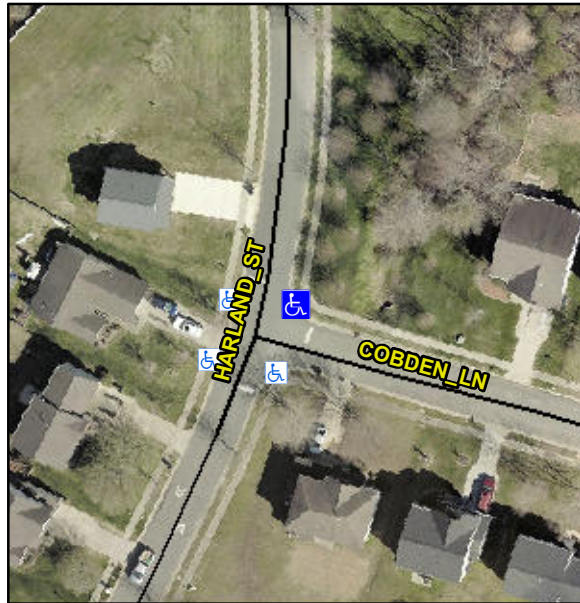
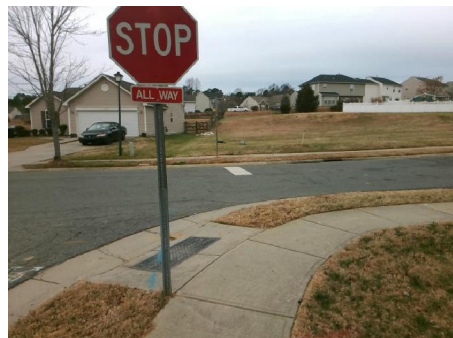
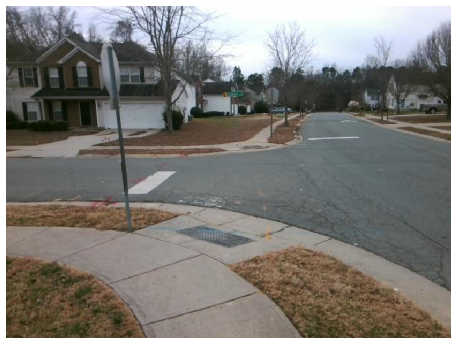
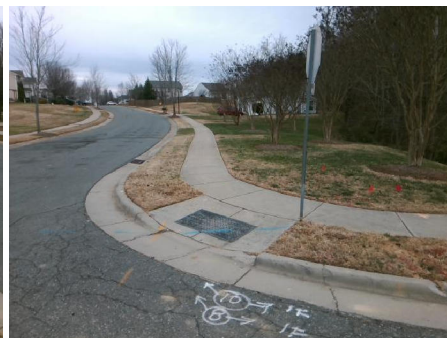
R304.2.2, R304.5.3

Possible Solutions:			Compliance	Description	Data	Compliance	Description	Data
Remove & Replace Curb Ramp With Two New Directional Ramps or Equivalent.	N/A	Ramp Length (in)	48.0	No	Ramp Slope (%)	13.2		
	Yes	Ramp Width (in)	48.0	No	Ramp XSlope (%)	4.8		
	N/A	Flare Type LT	N/A	N/A	Flare Type RT	N/A		
	N/A	Flare Slope LT (%)	N/A	N/A	Flare Slope RT (%)	N/A		
	N/A	Flare Traversable LT?	N/A	N/A	Flare Traversable RT?	N/A		
	N/A	Landing Length (in)	N/A	N/A	DWS Provided?	N/A		
	N/A	Landing Width (in)	N/A	N/A	DWS Contrast?	N/A		
	N/A	Landing Slope (%)	N/A	N/A	DWS Length (in)	N/A		
	N/A	Landing X Slope (%)	N/A	N/A	DWS Full Width?	N/A		
	N/A	Landing Curb? (Y/N)	N/A	N/A	DWS Offset (in)	N/A		
Surveyor Notes: N/A	N/A	Shared Landing?	N/A					
	N/A	Gutter Ponding?	N/A	N/A	Gutter Slope (%)	N/A		
	N/A	Gutter Lip Ht (in)	N/A	N/A	Gutter X Slope (%)	N/A		
	N/A	Painted X Walk1?	No	N/A	Painted X Walk2?	No		
		X Walk 1 Direction	To NW		X Walk 2 Direction	To SW

N/A	X Walk 1 Width (in)	N/A	N/A	X Walk 2 Width (in)	N/A		
		X Walk 1 Slope (%)	1.3		X Walk 2 Slope (%)	1.4		
		X Walk 1 X Slope (%)	1.6		X Walk 2 X Slope (%)	1.9		
	N/A	Ramp inside XWalk1?	N/A	N/A	Ramp inside XWalk2?	N/A		
		Road Slope (%)	3.3	N/A	Clear Space?	N/A		
PROW/ADA: R304.2.2, R304.5.3		Road X Slope (%)	2.6	N/A	Clear Space to XWalk (in)	N/A		
	N/A	Any Obstructions?	N/A	N/A	Storm Grate/Utility Hazard?	N/A		
		Obstruction Type			Storm Grate/Utility Type			
			N/A			N/A		
				Yes	Surface Condition? (G/P)	Good		
Total Cost:	\$	3200.00

Remove & Replace Curb Ramp With Two New Directional Ramps or Equivalent.
