Access Compliance Report

Public Rights-of-Way

(Curb Ramps)

Intersection ID: 19209	Main Street: LIVINGSTON_DR	Cross Street: SARDIS_RD	Location: NW
ADA ID: BC9622006BBE	Ramp Type: Perp	Initial Pass/Fail: Fail	Overall Compliance: No
			Severity Score: 13.75

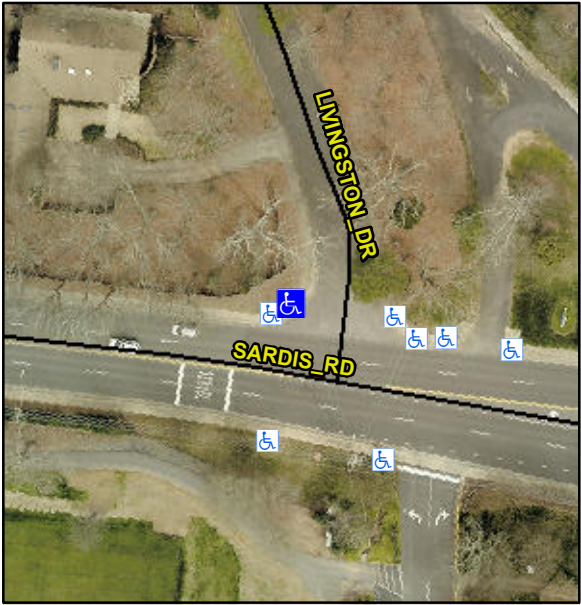
Possible Solutions:		Compliance	Description	Data
	Remove & Replace Entire Ramp.		No	Ramp Length (in)	60.0
			Yes	Ramp Width (in)	48.0
			N/A	Flare Type LT	N/A
			N/A	Flare Slope LT (%)	N/A
			N/A	Flare Traversable LT?	N/A
			N/A	Landing Length (in)	N/A
			N/A	Landing Width (in)	N/A
			N/A	Landing Slope (%)	N/A
			N/A	Landing X Slope (%)	N/A
<p>Surveyor Notes:</p> <p>N/A</p> <p>PROW/ADA:</p> <p>Not Found, R304.2.2, R304.5.3</p>			N/A	Flare Type RT	N/A
			N/A	Flare Slope RT (%)	N/A
			N/A	Flare Traversable RT?	N/A
			N/A	DWS Provided?	N/A
			N/A	DWS Contrast?	N/A
			N/A	DWS Length (in)	N/A
			N/A	DWS Full Width?	N/A
			N/A	DWS Offset (in)	N/A
			N/A	Gutter Ponding?	N/A
			N/A	Gutter Lip Ht (in)	N/A
			No	Painted X Walk1?	N/A
				X Walk 1 Direction	To SE
			N/A	X Walk 1 Width (in)	N/A
				X Walk 1 Slope (%)	0.1
				X Walk 1 X Slope (%)	1.9

N/A	Ramp inside XWalk1?	N/A
			N/A	Road Slope (%)	N/A
			N/A	Road X Slope (%)	N/A
			N/A	Any Obstructions?	N/A
				Obstruction Type	
Total Cost:			N/A	Storm Grate/Utility Hazard?	N/A
				Storm Grate/Utility Type	
			N/A		N/A
			Yes	Surface Condition? (G/P)	Good
