Access Compliance Report Public Rights-of-Way (Curb Ramps)

Intersection ID: 10020377 Main Street: BALLANTYNE_CORPORATE_PCross Street: N/A Location: NE

ADA ID: BC97925EA533 Ramp Type: BlendTrans2 Initial Pass/Fail: Fail Overall Compliance: No Severity Score: 12.5

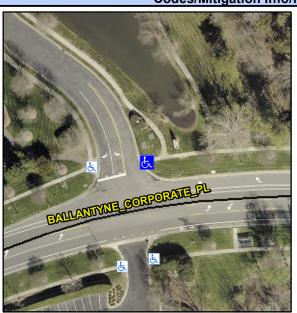
Not Found, R304.5.3

Comp	liance Description	Data	Comp	liance Description	Data
N/A	Ramp Length (in)	93.0	Yes	BlendTrans Slope (%)	1.1
Yes	Ramp Width (in)	48.0	No	BlendTrans XSlope (%)	5.7
N/A	Flare Type LT	N/A	N/A	Flare Type RT	N/A
N/A	Flare Slope LT (%)	N/A	N/A	Flare Slope RT (%)	N/A
N/A	Flare Traversable LT?	N/A	N/A	Flare Traversable RT?	N/A
N/A	Landing Length (in)	N/A	N/A	DWS Provided?	N/A
N/A	Landing Width (in)	N/A	N/A	DWS Contrast?	N/A
N/A	Landing Slope (%)	N/A	N/A	DWS Length (in)	N/A
N/A	Landing X Slope (%)	N/A	N/A	DWS Full Width?	N/A
N/A	Landing Curb? (Y/N)	N/A	N/A	DWS Offset (in)	N/A
N/A	Shared Landing?	N/A			
N/A	Gutter Ponding?	N/A	N/A	Gutter Slope (%)	N/A
N/A	Gutter Lip Ht (in)	N/A	N/A	Gutter X Slope (%)	N/A
N/A	Painted X Walk1?	No	N/A	Painted X Walk2?	N/A
	X Walk 1 Direction	To W		X Walk 2 Direction	N/A
	X Walk 1 Width (in)	N/A		X Walk 2 Width (in)	N/A
	X Walk 1 Slope (%)	2.0		X Walk 2 Slope (%)	N/A
	X Walk 1 X Slope (%)	3.4		X Walk 2 X Slope (%)	N/A

N/A	Ramp inside XWalk1?	N/A	N/A	Ramp inside XWalk2?	N/A
	Road Slope (%)	3.4		Clear Space?	N/A
	Road X Slope (%)	2.0	N/A	Clear Space to XWalk (in)	N/A
N/A	Any Obstructions?	N/A	N/A	Storm Grate/Utility Hazard?	N/A
	Obstruction Type			Storm Grate/Utility Type	
		N/A			N/A
			Yes	Surface Condition? (G/P)	Good
			No	Curb Slope (%)	13.3

Remove & Replace Curb Ramp With Two New Directional Ramps or Equivalent.
