## **Access Compliance Report Public Rights-of-Way** (Curb Ramps)

Intersection ID: 9211 Main Street: E SUGAR CREEK RD **Cross Street: GREENSBORO ST** Location: Ε **ADA ID: BC9F4F5CF0DE** Ramp Type: PerpDiag Initial Pass/Fail: Fail **Overall Compliance: No Severity Score:** 25

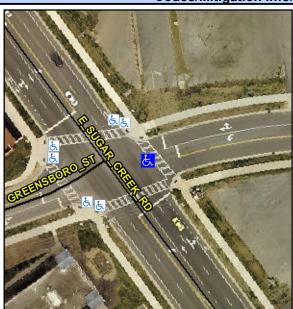
| Field Measurements/Component Compliance | | | | | |
|---|---|---|---|---|---|
| Yes | Ramp Width (in) | 52.0 | No | Ramp XSlope (%) | 7.0 |

**GREENSBORO** Street 1 Name Stop Condition-Street 2 Signal **E SUGAR CREEK** Street 2 Name Stop Condition-Street 1 Signal Possible Solutions: Remove & Replace Curb Ramp With **Two New Directional Ramps or** Equivalent. Surveyor Notes: N/A PROW/ADA: Not Found, R304.5.3
