Access Compliance Report

Public Rights-of-Way

(Curb Ramps)

Intersection ID: 24279	Main Street: EDENBRIDGE_LN	Cross Street: WINDYRUSH_RD	Location: E
ADA ID: BCA0A5ABC3B8	Ramp Type: PerpDiag	Initial Pass/Fail: Fail	Overall Compliance: No
			Severity Score: 21.25

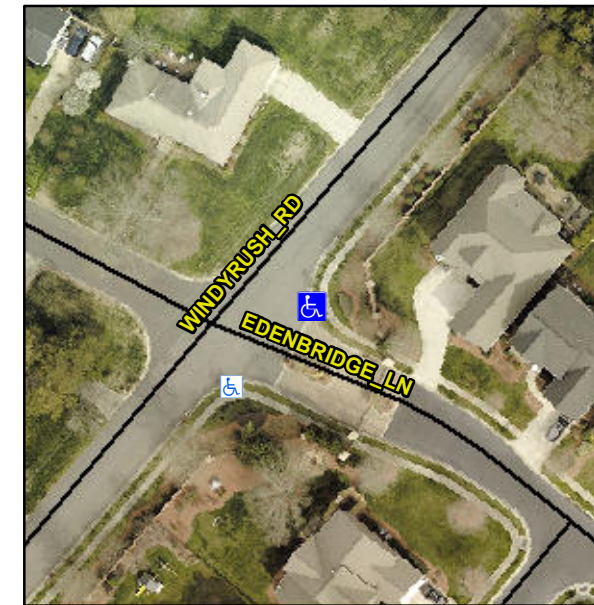
Not Found, R304.5.1, R304.2.2

Compliance	Description	Data	Compliance	Description	Data
N/A	Ramp Length (in)	47.0	No	Ramp Slope (%)	10.2
No	Ramp Width (in)	41.5	Yes	Ramp XSlope (%)	1.9
N/A	Flare Type LT	N/A	N/A	Flare Type RT	N/A
N/A	Flare Slope LT (%)	N/A	N/A	Flare Slope RT (%)	N/A
N/A	Flare Traversable LT?	N/A	N/A	Flare Traversable RT?	N/A
N/A	Landing Length (in)	N/A	N/A	DWS Provided?	N/A
N/A	Landing Width (in)	N/A	N/A	DWS Contrast?	N/A
N/A	Landing Slope (%)	N/A	N/A	DWS Length (in)	N/A
N/A	Landing X Slope (%)	N/A	N/A	DWS Full Width?	N/A
N/A	Landing Curb? (Y/N)	N/A	N/A	DWS Offset (in)	N/A
N/A	Shared Landing?	N/A			
N/A	Gutter Ponding?	N/A	N/A	Gutter Slope (%)	N/A
N/A	Gutter Lip Ht (in)	N/A	N/A	Gutter X Slope (%)	N/A
N/A	Painted X Walk1?	No	N/A	Painted X Walk2?	No
	X Walk 1 Direction	To NW		X Walk 2 Direction	To SW
N/A	X Walk 1 Width (in)	N/A	N/A	X Walk 2 Width (in)	N/A
	X Walk 1 Slope (%)	3.4		X Walk 2 Slope (%)	0.2
	X Walk 1 X Slope (%)	2.5		X Walk 2 X Slope (%)	3.1

N/A	Ramp inside XWalk1?	N/A	N/A	Ramp inside XWalk2?	N/A
	Road Slope (%)	2.2	N/A	Clear Space?	N/A
	Road X Slope (%)	2.8	N/A	Clear Space to XWalk (in)	N/A
N/A	Any Obstructions?	N/A	N/A	Storm Grate/Utility Hazard?	N/A
	Obstruction Type			Storm Grate/Utility Type	
		N/A			N/A
			Yes	Surface Condition? (G/P)	Good

Remove & Replace Curb Ramp With Two New Directional Ramps or Equivalent.
