Access Compliance Report

Public Rights-of-Way

(Curb Ramps)

Intersection ID: N/A	Main Street: RIDGE_OAK_DR	Cross Street: CAROLINA_CROSSING_DR	Location: NW
ADA ID: BCA5F40345FE	Ramp Type: Perp	Initial Pass/Fail: Fail	Overall Compliance: No
Severity Score: 10			
Codes/Mitigation Info/Possible Solution		Field Measurements/Component Compliance

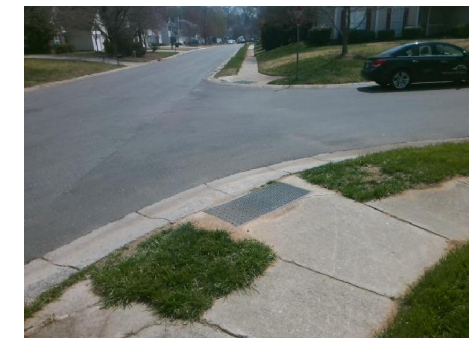
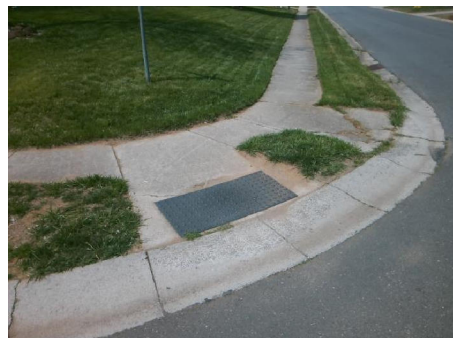
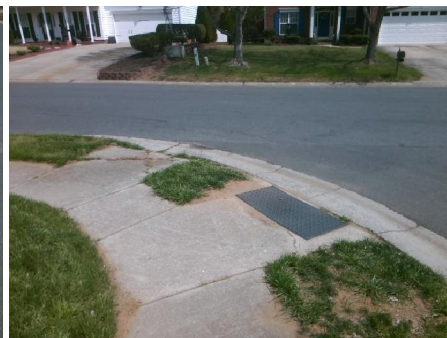
Not Found, R304.5.1, R304.5.3

Compliance	Description	Data	Compliance	Description	Data
N/A	Ramp Length (in)	91.0	Yes	Ramp Slope (%)	6.0
No	Ramp Width (in)	40.0	No	Ramp XSlope (%)	3.6
N/A	Flare Type LT	N/A	N/A	Flare Type RT	N/A
N/A	Flare Slope LT (%)	N/A	N/A	Flare Slope RT (%)	N/A
N/A	Flare Traversable LT?	N/A	N/A	Flare Traversable RT?	N/A
N/A	Landing Length (in)	N/A	N/A	DWS Provided?	N/A
N/A	Landing Width (in)	N/A	N/A	DWS Contrast?	N/A
N/A	Landing Slope (%)	N/A	N/A	DWS Length (in)	N/A
N/A	Landing X Slope (%)	N/A	N/A	DWS Full Width?	N/A
N/A	Landing Curb? (Y/N)	N/A	N/A	DWS Offset (in)	N/A
N/A	Shared Landing?	N/A			
N/A	Gutter Ponding?	N/A	N/A	Gutter Slope (%)	N/A
N/A	Gutter Lip Ht (in)	N/A	N/A	Gutter X Slope (%)	N/A
N/A	Painted X Walk1?	No	N/A	Painted X Walk2?	N/A
	X Walk 1 Direction	To SE		X Walk 2 Direction	N/A
N/A	X Walk 1 Width (in)	N/A	N/A	X Walk 2 Width (in)	N/A
	X Walk 1 Slope (%)	1.0		X Walk 2 Slope (%)	N/A
	X Walk 1 X Slope (%)	1.5		X Walk 2 X Slope (%)	N/A

N/A	Ramp inside XWalk1?	N/A	N/A	Ramp inside XWalk2?	N/A
	Road Slope (%)	N/A	N/A	Clear Space?	N/A
	Road X Slope (%)	N/A	N/A	Clear Space to XWalk (in)	N/A
N/A	Any Obstructions?	N/A	N/A	Storm Grate/Utility Hazard?	N/A
	Obstruction Type			Storm Grate/Utility Type	
		N/A			N/A
			Yes	Surface Condition? (G/P)	Good

Possible Solutions:

Remove & Replace Entire Ramp.
