Access Compliance Report

Public Rights-of-Way

(Curb Ramps)

Intersection ID: 7570	Main Street: BEATTIES_FORD_RD	Cross Street: SIR_BAILEY_DR	Location: NW
ADA ID: BCBDE6A6868B	Ramp Type: PerpDiag	Initial Pass/Fail: Fail	Overall Compliance: No
Severity Score: 25			
Codes/Mitigation Info/Possible Solution		Field Measurements/Component Compliance

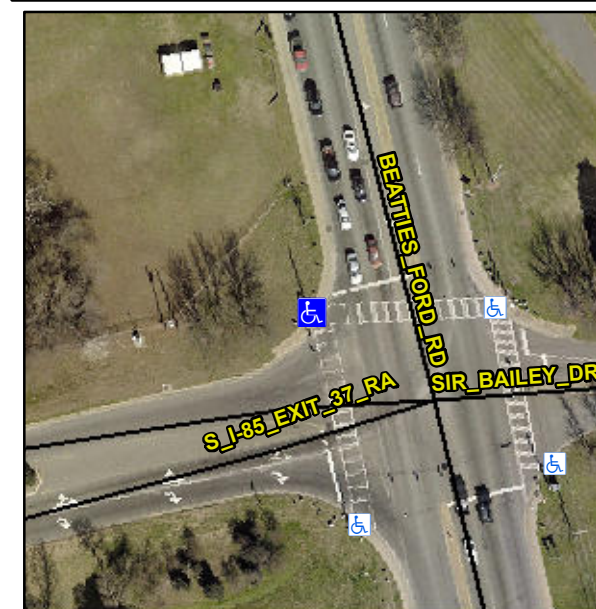
Not Found, R304.2.2

Compliance	Description	Data	Compliance	Description	Data
N/A	Ramp Length (in)	56.0	No	Ramp Slope (%)	12.8
Yes	Ramp Width (in)	48.0	Yes	Ramp XSlope (%)	1.8
N/A	Flare Type LT	N/A	N/A	Flare Type RT	N/A
N/A	Flare Slope LT (%)	N/A	N/A	Flare Slope RT (%)	N/A
N/A	Flare Traversable LT?	N/A	N/A	Flare Traversable RT?	N/A
N/A	Landing Length (in)	N/A	N/A	DWS Provided?	N/A
N/A	Landing Width (in)	N/A	N/A	DWS Contrast?	N/A
N/A	Landing Slope (%)	N/A	N/A	DWS Length (in)	N/A
N/A	Landing X Slope (%)	N/A	N/A	DWS Full Width?	N/A
N/A	Landing Curb? (Y/N)	N/A	N/A	DWS Offset (in)	N/A
N/A	Shared Landing?	N/A			
N/A	Gutter Ponding?	N/A	N/A	Gutter Slope (%)	N/A
N/A	Gutter Lip Ht (in)	N/A	N/A	Gutter X Slope (%)	N/A
N/A	Painted X Walk1?	Yes	N/A	Painted X Walk2?	Yes
	X Walk 1 Direction	To S		X Walk 2 Direction	To E
N/A	X Walk 1 Width (in)	112.0	N/A	X Walk 2 Width (in)	110.0
	X Walk 1 Slope (%)	1.3		X Walk 2 Slope (%)	3.5
	X Walk 1 X Slope (%)	2.5		X Walk 2 X Slope (%)	6.5

N/A	Ramp inside XWalk1?	Yes	N/A	Ramp inside XWalk2?	Yes
	Road Slope (%)	1.4	N/A	Clear Space?	N/A
	Road X Slope (%)	2.2	N/A	Clear Space to XWalk (in)	N/A
N/A	Any Obstructions?	N/A	N/A	Storm Grate/Utility Hazard?	N/A
	Obstruction Type			Storm Grate/Utility Type	
		N/A			N/A
		Yes		Surface Condition? (G/P)	Good

Remove & Replace Curb Ramp With Two New Directional Ramps or Equivalent.
