Access Compliance Report

Public Rights-of-Way

(Curb Ramps)

Intersection ID: 53893	Main Street: PERTH_MOOR_RD	Cross Street: HAMILTON_BRIDGE_RD	Location: SW
ADA ID: BCBFE5525FC2	Ramp Type: BlendTrans1	Initial Pass/Fail: Fail	Overall Compliance: No
		Severity Score: 8.75

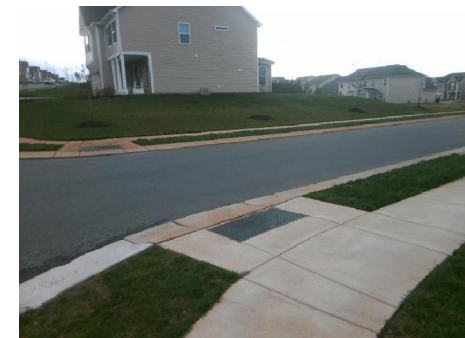
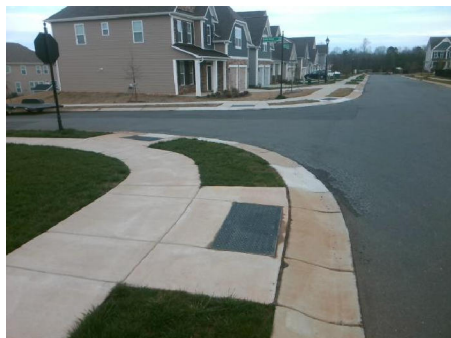
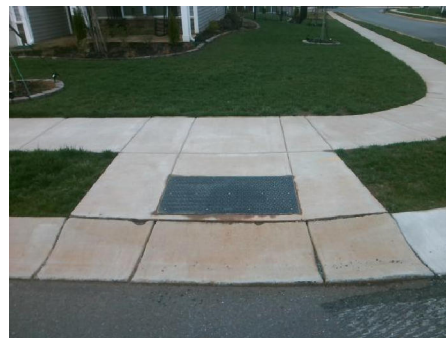
Not Found, R304.5.1

Compliance	Description	Data	Compliance	Description	Data
N/A	Ramp Length (in)	47.0	Yes	BlendTrans Slope (%)	4.0
No	Ramp Width (in)	47.0	Yes	BlendTrans XSlope (%)	1.0
N/A	Flare Type LT	N/A	N/A	Flare Type RT	N/A
N/A	Flare Slope LT (%)	N/A	N/A	Flare Slope RT (%)	N/A
N/A	Flare Traversable LT?	N/A	N/A	Flare Traversable RT?	N/A
N/A	Landing Length (in)	N/A	N/A	DWS Provided?	N/A
N/A	Landing Width (in)	N/A	N/A	DWS Contrast?	N/A
N/A	Landing Slope (%)	N/A	N/A	DWS Length (in)	N/A
N/A	Landing X Slope (%)	N/A	N/A	DWS Full Width?	N/A
N/A	Landing Curb? (Y/N)	N/A	N/A	DWS Offset (in)	N/A
N/A	Shared Landing?	N/A			
N/A	Gutter Ponding?	N/A	N/A	Gutter Slope (%)	N/A
N/A	Gutter Lip Ht (in)	1.0	N/A	Gutter X Slope (%)	N/A
N/A	Painted X Walk1?	No	N/A	Painted X Walk2?	N/A
	X Walk 1 Direction	To E		X Walk 2 Direction	N/A
	X Walk 1 Width (in)	N/A		X Walk 2 Width (in)	N/A
	X Walk 1 Slope (%)	1.1		X Walk 2 Slope (%)	N/A
	X Walk 1 X Slope (%)	1.2		X Walk 2 X Slope (%)	N/A

N/A	Ramp inside XWalk1?	N/A	N/A	Ramp inside XWalk2?	N/A
	Road Slope (%)	1.2		Clear Space?	N/A
	Road X Slope (%)	1.1	N/A	Clear Space to XWalk (in)	N/A
N/A	Any Obstructions?	N/A	N/A	Storm Grate/Utility Hazard?	N/A
	Obstruction Type			Storm Grate/Utility Type	
		N/A			N/A
			Yes	Surface Condition? (G/P)	Good
			No	Curb Slope (%)	11.4

Remove & Replace Curb Ramp With Two New Directional Ramps or Equivalent.
