# Access Compliance Report

## Public Rights-of-Way

### (Curb Ramps)

Intersection ID: 20280	Main Street: CEDAR_HILL_DR	Cross Street: LARIX_DR	Location: SE
ADA ID: BCC2227C47EC	Ramp Type: PerpDiag	Initial Pass/Fail: Fail	Overall Compliance: No
			Severity Score: 26.25

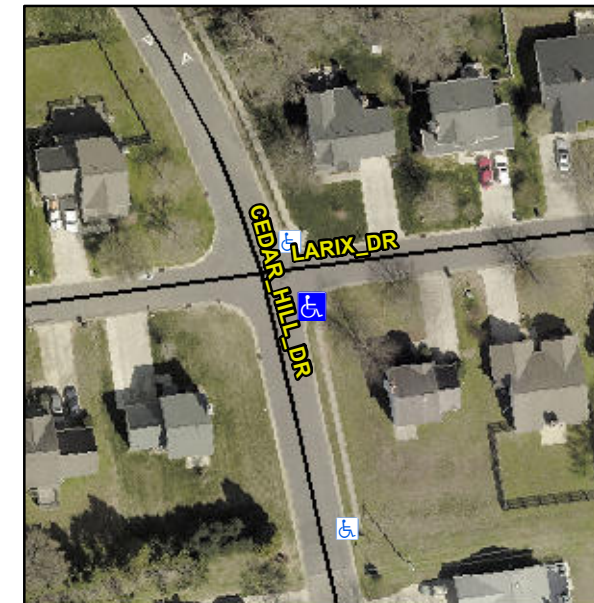
**Not Found, R304.2.2, R304.5.3**

Compliance	Description	Data	Compliance	Description	Data
N/A	Ramp Length (in)	50.0	No	Ramp Slope (%)	13.0
Yes	Ramp Width (in)	52.0	No	Ramp XSlope (%)	4.3
N/A	Flare Type LT	N/A	N/A	Flare Type RT	N/A
N/A	Flare Slope LT (%)	N/A	N/A	Flare Slope RT (%)	N/A
N/A	Flare Traversable LT?	N/A	N/A	Flare Traversable RT?	N/A
N/A	Landing Length (in)	N/A	N/A	DWS Provided?	N/A
N/A	Landing Width (in)	N/A	N/A	DWS Contrast?	N/A
N/A	Landing Slope (%)	N/A	N/A	DWS Length (in)	N/A
N/A	Landing X Slope (%)	N/A	N/A	DWS Full Width?	N/A
N/A	Landing Curb? (Y/N)	N/A	N/A	DWS Offset (in)	N/A
N/A	Shared Landing?	N/A			
N/A	Gutter Ponding?	N/A	N/A	Gutter Slope (%)	N/A
N/A	Gutter Lip Ht (in)	N/A	N/A	Gutter X Slope (%)	N/A
N/A	Painted X Walk1?	No	N/A	Painted X Walk2?	No
	X Walk 1 Direction	To N		X Walk 2 Direction	To W
N/A	X Walk 1 Width (in)	N/A	N/A	X Walk 2 Width (in)	N/A
	X Walk 1 Slope (%)	0.3		X Walk 2 Slope (%)	5.7
	X Walk 1 X Slope (%)	3.7		X Walk 2 X Slope (%)	1.5

N/A	Ramp inside XWalk1?	N/A	N/A	Ramp inside XWalk2?	N/A
	Road Slope (%)	2.1	N/A	Clear Space?	N/A
	Road X Slope (%)	1.5	N/A	Clear Space to XWalk (in)	N/A
N/A	Any Obstructions?	N/A	N/A	Storm Grate/Utility Hazard?	N/A
	Obstruction Type			Storm Grate/Utility Type	
		N/A			N/A
			Yes	Surface Condition? (G/P)	Good

**Remove & Replace Curb Ramp With Two New Directional Ramps or Equivalent.**
