Access Compliance Report

Public Rights-of-Way

(Curb Ramps)

Intersection ID: 10027081	Main Street: GALLERIA_BV	Cross Street: N/A	Location: SE
ADA ID: BCC77ABCB62	Ramp Type: Perp	Initial Pass/Fail: Fail	Overall Compliance: No
Severity Score: 22.5			
Codes/Mitigation Info/Possible Solution		Field Measurements/Component Compliance

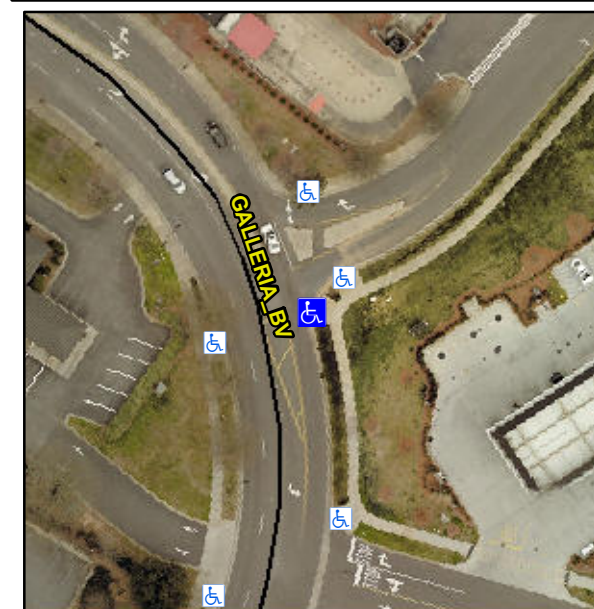
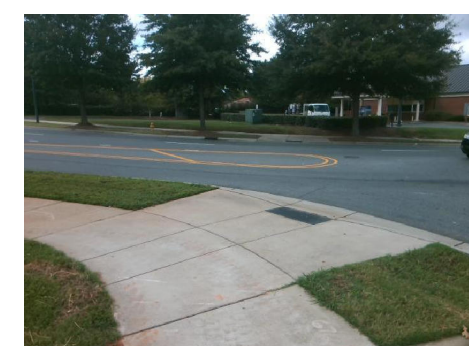
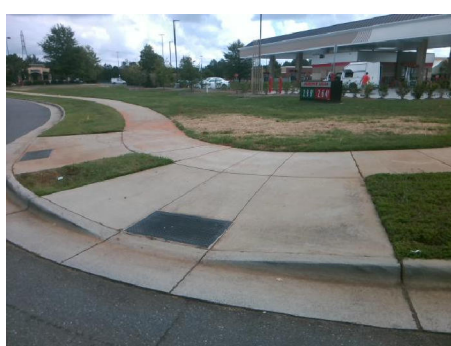
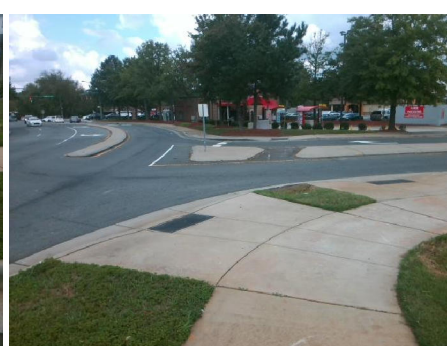
Not Found, R304.5.1, R304.2.2, R304.5.3

Compliance	Description	Data	Compliance	Description	Data
N/A	Ramp Length (in)	94.0	No	Ramp Slope (%)	9.3
No	Ramp Width (in)	37.0	No	Ramp XSlope (%)	3.2
N/A	Flare Type LT	N/A	N/A	Flare Type RT	N/A
N/A	Flare Slope LT (%)	N/A	N/A	Flare Slope RT (%)	N/A
N/A	Flare Traversable LT?	N/A	N/A	Flare Traversable RT?	N/A
N/A	Landing Length (in)	N/A	N/A	DWS Provided?	N/A
N/A	Landing Width (in)	N/A	N/A	DWS Contrast?	N/A
N/A	Landing Slope (%)	N/A	N/A	DWS Length (in)	N/A
N/A	Landing X Slope (%)	N/A	N/A	DWS Full Width?	N/A
N/A	Landing Curb? (Y/N)	N/A	N/A	DWS Offset (in)	N/A
N/A	Shared Landing?	N/A			
N/A	Gutter Ponding?	N/A	N/A	Gutter Slope (%)	N/A
N/A	Gutter Lip Ht (in)	N/A	N/A	Gutter X Slope (%)	N/A
N/A	Painted X Walk1?	No	N/A	Painted X Walk2?	N/A
	X Walk 1 Direction	To W		X Walk 2 Direction	N/A
N/A	X Walk 1 Width (in)	N/A	N/A	X Walk 2 Width (in)	N/A
	X Walk 1 Slope (%)	3.1		X Walk 2 Slope (%)	N/A
	X Walk 1 X Slope (%)	0.5		X Walk 2 X Slope (%)	N/A

N/A	Ramp inside XWalk1?	N/A	N/A	Ramp inside XWalk2?	N/A
	Road Slope (%)	N/A	N/A	Clear Space?	N/A
	Road X Slope (%)	N/A	N/A	Clear Space to XWalk (in)	N/A
N/A	Any Obstructions?	N/A	N/A	Storm Grate/Utility Hazard?	N/A
	Obstruction Type			Storm Grate/Utility Type	
		N/A			N/A
			Yes	Surface Condition? (G/P)	Good

Remove & Replace Entire Ramp.
