# Access Compliance Report

## Public Rights-of-Way

### (Curb Ramps)

Intersection ID: 12766	Main Street: S_GRAHAM_ST	Cross Street: W_PALMER_ST	Location: N
ADA ID: BCCBF8B244BB	Ramp Type: PerpDiag	Initial Pass/Fail: Fail	Overall Compliance: No
Severity Score: 26.25			
Codes/Mitigation Info/Possible Solution		Field Measurements/Component Compliance

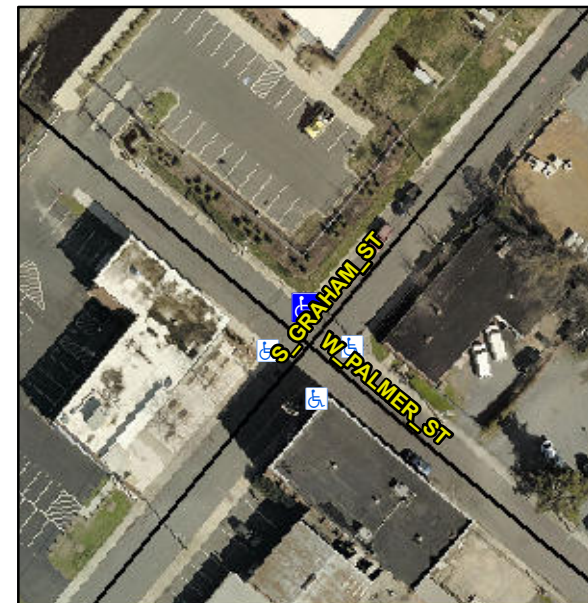
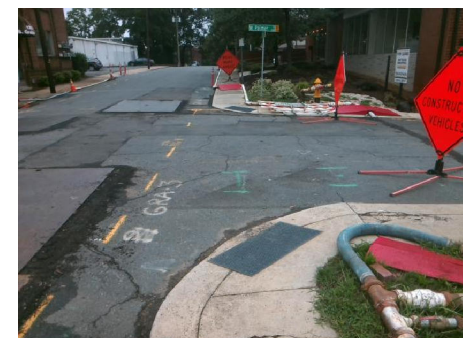
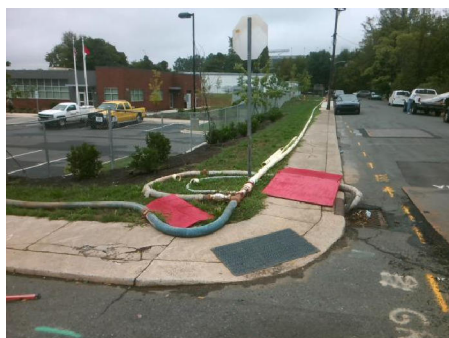
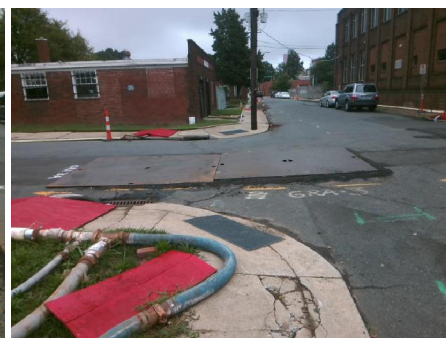
Compliance	Description	Data	Compliance	Description	Data
N/A	Ramp Length (in)	41.0	No	Ramp Slope (%)	13.5
Yes	Ramp Width (in)	48.0	No	Ramp XSlope (%)	2.5
N/A	Flare Type LT	N/A	N/A	Flare Type RT	N/A
N/A	Flare Slope LT (%)	N/A	N/A	Flare Slope RT (%)	N/A
N/A	Flare Traversable LT?	N/A	N/A	Flare Traversable RT?	N/A
N/A	Landing Length (in)	N/A	N/A	DWS Provided?	N/A
N/A	Landing Width (in)	N/A	N/A	DWS Contrast?	N/A
N/A	Landing Slope (%)	N/A	N/A	DWS Length (in)	N/A
N/A	Landing X Slope (%)	N/A	N/A	DWS Full Width?	N/A
N/A	Landing Curb? (Y/N)	N/A	N/A	DWS Offset (in)	N/A
N/A	Shared Landing?	N/A			
N/A	Gutter Ponding?	N/A	N/A	Gutter Slope (%)	N/A
N/A	Gutter Lip Ht (in)	N/A	N/A	Gutter X Slope (%)	N/A
N/A	Painted X Walk1?	No	N/A	Painted X Walk2?	No
	X Walk 1 Direction	To SW		X Walk 2 Direction	To SE
N/A	X Walk 1 Width (in)	N/A	N/A	X Walk 2 Width (in)	N/A
	X Walk 1 Slope (%)	5.0		X Walk 2 Slope (%)	7.7
	X Walk 1 X Slope (%)	3.9		X Walk 2 X Slope (%)	1.9

N/A	Ramp inside XWalk1?	N/A	N/A	Ramp inside XWalk2?	N/A
	Road Slope (%)	1.1	N/A	Clear Space?	N/A
	Road X Slope (%)	7.0	N/A	Clear Space to XWalk (in)	N/A
N/A	Any Obstructions?	N/A	N/A	Storm Grate/Utility Hazard?	N/A
	Obstruction Type			Storm Grate/Utility Type	
		N/A			N/A
		Yes		Surface Condition? (G/P)	Good

**Remove & Replace Curb Ramp With Two New Directional Ramps or Equivalent.**

**R304.2.2, R304.5.3**
