## **Access Compliance Report Public Rights-of-Way** (Curb Ramps)

Intersection ID: 7850 Main Street: MUNSEE\_ST Cross Street: YUMA\_ST Location: NE **Overall Compliance: No** ADA ID: BCE029BEA5D3 Ramp Type: Para Initial Pass/Fail: Fail **Severity Score:** 25

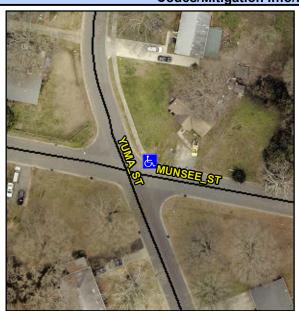
Field Measurements/Component Compliance							
Compliance Description		Data	Comp	liance Description	Data		
N/A	Ramp Length LT (in)	27.0	N/A	Ramp Length RT (in)	26.5		
Yes	Ramp Width LT (in)	60.0	Yes	Ramp Width RT (in)	72.0		
No	Ramp Slope LT (%)	12.7	Yes	Ramp Slope RT (%)	0.2		
Yes	Ramp XSlope LT (%)	1.8	Yes	Ramp XSlope RT (%)	1.8		
N/A	Landing Length (in)	N/A	N/A	DWS Provided?	N/A		
N/A	Landing Width (in)	N/A	N/A	DWS Contrast?	N/A		
N/A	Landing Slope (%)	N/A	N/A	DWS Length (in)	N/A		
N/A	Landing X Slope (%)	N/A	N/A	DWS Full Width?	N/A		
N/A	Landing Curb? (Y/N)	N/A	N/A	DWS Offset (in)	N/A		
N/A	Shared Landing?	N/A					
N/A	Gutter Ponding?	N/A	N/A	Gutter Slope (%)	N/A		
N/A	Gutter Lip Ht (in)	1.5	N/A	Gutter X Slope (%)	N/A		
N/A	Painted X Walk1?	No	N/A	Painted X Walk2?	N/A		
	X Walk 1 Direction	To S		X Walk 2 Direction	N/A		
N/A	X Walk 1 Width (in)	N/A	N/A	X Walk 2 Width (in)	N/A		
	X Walk 1 Slope (%)	4.3		X Walk 2 Slope (%)	N/A

X Walk 1 X Slope (%)	3.4		X Walk 2 X Slope (%)	N/A		
N/A	Ramp inside XWalk1?	N/A	N/A	Ramp inside XWalk2?	N/A		
	Road Slope (%)	N/A	N/A	Clear Space?	N/A		
	Road X Slope (%)	N/A	N/A	Clear Space to XWalk (in)	N/A		
N/A	Any Obstructions?	N/A	N/A	Storm Grate/Utility Hazard?	N/A		
	Obstruction Type			Storm Grate/Utility Type			
		N/A			N/A		
			Yes	Surface Condition? (G/P)	Good		
			N/A	Curb Slope (%)	N/A

Possible Solutions:	Cor
Remove & Replace Entire Ramp.	N/A
•	Yes
	No
	Yes
	N/A
	N/A
Surveyor Notes:	N/A
RT RP < 5%, NO RT SW	N/A
·	N/A
	N/A
	N/A
PROW/ADA:	N/A
R304.3.2	N/A
	N/A
	N/A

Total Cost: 1600.00
