## Access Compliance Report Public Rights-of-Way (Curb Ramps)

Intersection ID: 50100 Main Street: PECAN\_FLATS\_DR Cross Street: SUNRISE\_VIEW\_DR Location: SE

ADA ID: BCEA274593CD Ramp Type: Perp Initial Pass/Fail: Fail Overall Compliance: No Severity Score: 8.75

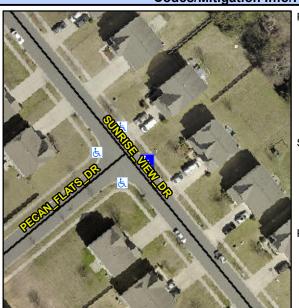
Not Found, R304.5.1

Field Measurements/Component Compliance							
Compliance Description		Data	Comp	liance Description	Data		
N/A	Ramp Length (in)	69.0	Yes	Ramp Slope (%)	6.3		
No	Ramp Width (in)	47.0	Yes	Ramp XSlope (%)	0.3		
N/A	Flare Type LT	N/A	N/A	Flare Type RT	N/A		
N/A	Flare Slope LT (%)	N/A	N/A	Flare Slope RT (%)	N/A		
N/A	Flare Traversable LT?	N/A	N/A	Flare Traversable RT?	N/A		
N/A	Landing Length (in)	N/A	N/A	DWS Provided?	N/A		
N/A	Landing Width (in)	N/A	N/A	DWS Contrast?	N/A		
N/A	Landing Slope (%)	N/A	N/A	DWS Length (in)	N/A		
N/A	Landing X Slope (%)	N/A	N/A	DWS Full Width?	N/A		
N/A	Landing Curb? (Y/N)	N/A	N/A	DWS Offset (in)	N/A		
N/A	Shared Landing?	N/A					
N/A	Gutter Ponding?	N/A	N/A	Gutter Slope (%)	N/A		
N/A	Gutter Lip Ht (in)	N/A	N/A	Gutter X Slope (%)	N/A		
N/A	Painted X Walk1?	No	N/A	Painted X Walk2?	N/A		
	X Walk 1 Direction	To SW		X Walk 2 Direction	N/A		
N/A	X Walk 1 Width (in)	N/A	N/A	X Walk 2 Width (in)	N/A

X Walk 1 Slope (%)	1.4		X Walk 2 Slope (%)	N/A		
	X Walk 1 X Slope (%)	1.0		X Walk 2 X Slope (%)	N/A		
N/A	Ramp inside XWalk1?	N/A	N/A	Ramp inside XWalk2?	N/A		
	Road Slope (%)	N/A	N/A	Clear Space?	N/A		
	Road X Slope (%)	N/A	N/A	Clear Space to XWalk (in)	N/A		
N/A	Any Obstructions?	N/A	N/A	Storm Grate/Utility Hazard?	N/A		
	Obstruction Type			Storm Grate/Utility Type			
		N/A			N/A		
			Yes	Surface Condition? (G/P)	Good

Remove & Replace Entire Ramp.

Total Cost: \$ 1850.00
