Access Compliance Report

Public Rights-of-Way

(Curb Ramps)

Intersection ID: 43495	Main Street: PROVIDENCE_LN	Cross Street: PRESCOTT_HILL_AV	Location: SE
ADA ID: BCF4E4552C3E	Ramp Type: PerpDiag	Initial Pass/Fail: Fail	Overall Compliance: No
Severity Score: 22.5			
Codes/Mitigation Info/Possible Solution		Field Measurements/Component Compliance

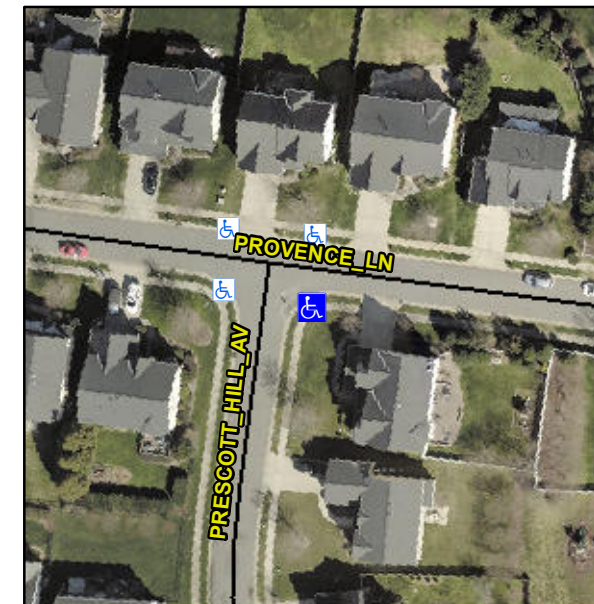
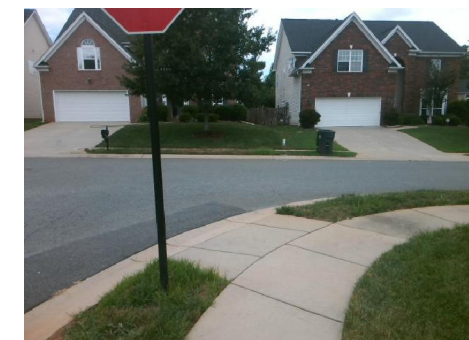
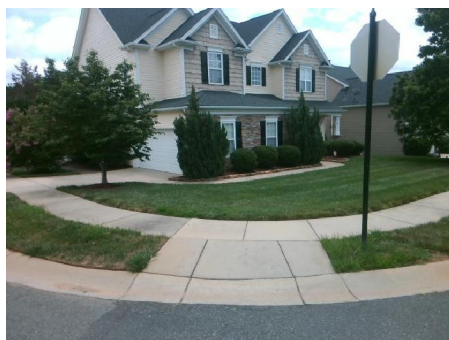
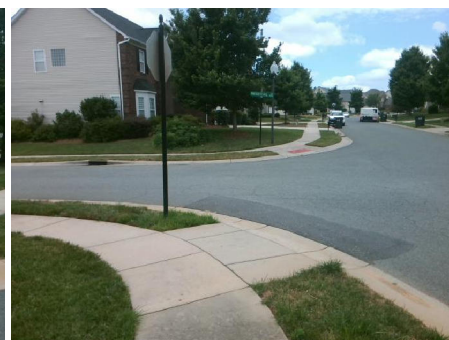
Not Found, R304.5.1, R304.2.2, R304.5.3

Compliance	Description	Data	Compliance	Description	Data
N/A	Ramp Length (in)	46.0	No	Ramp Slope (%)	10.2
No	Ramp Width (in)	43.5	No	Ramp XSlope (%)	2.3
N/A	Flare Type LT	N/A	N/A	Flare Type RT	N/A
N/A	Flare Slope LT (%)	N/A	N/A	Flare Slope RT (%)	N/A
N/A	Flare Traversable LT?	N/A	N/A	Flare Traversable RT?	N/A
N/A	Landing Length (in)	N/A	N/A	DWS Provided?	N/A
N/A	Landing Width (in)	N/A	N/A	DWS Contrast?	N/A
N/A	Landing Slope (%)	N/A	N/A	DWS Length (in)	N/A
N/A	Landing X Slope (%)	N/A	N/A	DWS Full Width?	N/A
N/A	Landing Curb? (Y/N)	N/A	N/A	DWS Offset (in)	N/A
N/A	Shared Landing?	N/A			
N/A	Gutter Ponding?	N/A	N/A	Gutter Slope (%)	N/A
N/A	Gutter Lip Ht (in)	N/A	N/A	Gutter X Slope (%)	N/A
N/A	Painted X Walk1?	No	N/A	Painted X Walk2?	No
	X Walk 1 Direction	To NE		X Walk 2 Direction	To NW
N/A	X Walk 1 Width (in)	N/A	N/A	X Walk 2 Width (in)	N/A
	X Walk 1 Slope (%)	3.8		X Walk 2 Slope (%)	3.9
	X Walk 1 X Slope (%)	1.6		X Walk 2 X Slope (%)	4.4

N/A	Ramp inside XWalk1?	N/A	N/A	Ramp inside XWalk2?	N/A
	Road Slope (%)	1.8	N/A	Clear Space?	N/A
	Road X Slope (%)	1.1	N/A	Clear Space to XWalk (in)	N/A
N/A	Any Obstructions?	N/A	N/A	Storm Grate/Utility Hazard?	N/A
	Obstruction Type			Storm Grate/Utility Type	
		N/A			N/A
			Yes	Surface Condition? (G/P)	Good

Possible Solutions:

Remove & Replace Curb Ramp With Two New Directional Ramps or Equivalent.
