## Access Compliance Report Public Rights-of-Way (Curb Ramps)

Intersection ID: 13234 Main Street: ABBEYDALE\_DR Cross Street: N\_SHARON\_AMITY\_RD Location: S

ADA ID: BCF50186776A Ramp Type: Perp Initial Pass/Fail: Fail Overall Compliance: No Severity Score: 12.5

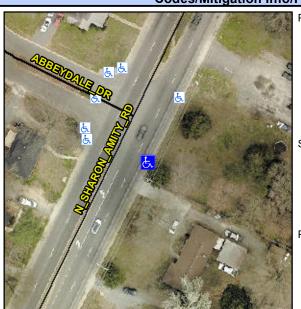
Field Measurements/Component Compliance						
Comp	liance Description	Data	Comp	liance Description	Data	
N/A	Ramp Length (in)	55.5	No	Ramp Slope (%)	11.2	
Yes	Ramp Width (in)	50.5	Yes	Ramp XSlope (%)	0.8	
N/A	Flare Type LT	N/A	N/A	Flare Type RT	N/A	
N/A	Flare Slope LT (%)	N/A	N/A	Flare Slope RT (%)	N/A	
N/A	Flare Traversable LT?	N/A	N/A	Flare Traversable RT?	N/A	
N/A	Landing Length (in)	N/A	N/A	DWS Provided?	N/A	
N/A	Landing Width (in)	N/A	N/A	DWS Contrast?	N/A	
N/A	Landing Slope (%)	N/A	N/A	DWS Length (in)	N/A	
N/A	Landing X Slope (%)	N/A	N/A	DWS Full Width?	N/A	
N/A	Landing Curb? (Y/N)	N/A	N/A	DWS Offset (in)	N/A	
N/A	Shared Landing?	N/A				
N/A	Gutter Ponding?	N/A	N/A	Gutter Slope (%)	N/A	
N/A	Gutter Lip Ht (in)	N/A	N/A	Gutter X Slope (%)	N/A	
N/A	Painted X Walk1?	No	N/A	Painted X Walk2?	N/A	
	X Walk 1 Direction	To NW		X Walk 2 Direction	N/A	
N/A	X Walk 1 Width (in)	N/A	N/A	X Walk 2 Width (in)	N/A	
	X Walk 1 Slope (%)	3.9		X Walk 2 Slope (%)	N/A

X Walk 1 X Slope (%)	1.1		X Walk 2 X Slope (%)	N/A	
N/A	Ramp inside XWalk1?	N/A	N/A	Ramp inside XWalk2?	N/A	
	Road Slope (%)	N/A	N/A	Clear Space?	N/A	
	Road X Slope (%)	N/A	N/A	Clear Space to XWalk (in)	N/A	
N/A	Any Obstructions?	N/A	N/A	Storm Grate/Utility Hazard?	N/A	
	Obstruction Type			Storm Grate/Utility Type		
		N/A			N/A	
			Yes	Surface Condition? (G/P)	Good	
The same

POSSIBLE SOLUTION			
Possible Solutions:	C		
Remove & Replace Entire Ramp.			
	Ye		
	N/		
Surveyor Notes:	N/		
N/A	N/		
	N/		
	N/		
	N/		
PROW/ADA:	N/		
Not Found, R304.2.2	N/		
	N/		
	N/

Total Cost: \$ 1850.00
