# Access Compliance Report

## Public Rights-of-Way

### (Curb Ramps)

Intersection ID: 29978	Main Street: ALBANS_LN	Cross Street: BARVAS_ST	Location: NW
ADA ID: BD0474C37294	Ramp Type: PerpDiag	Initial Pass/Fail: Fail	Overall Compliance: No
Severity Score: 10			
Codes/Mitigation Info/Possible Solution		Field Measurements/Component Compliance

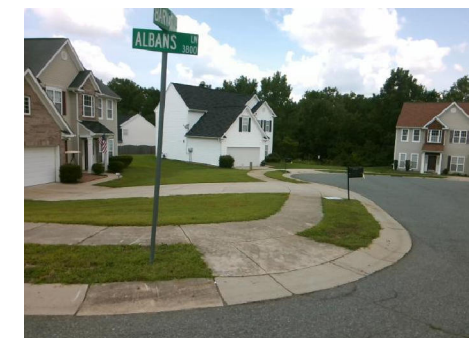
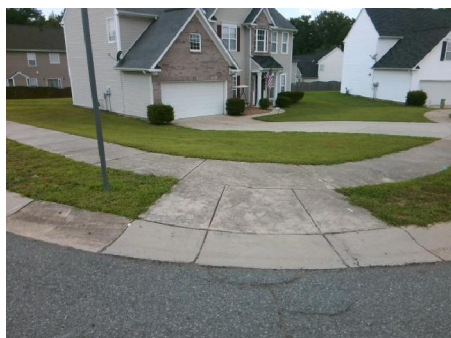
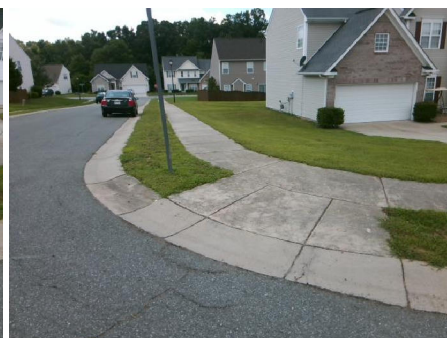
**Not Found, R304.5.1, R304.5.3**

Compliance	Description	Data	Compliance	Description	Data
N/A	Ramp Length (in)	48.0	Yes	Ramp Slope (%)	6.4
No	Ramp Width (in)	36.0	No	Ramp XSlope (%)	4.9
N/A	Flare Type LT	N/A	N/A	Flare Type RT	N/A
N/A	Flare Slope LT (%)	N/A	N/A	Flare Slope RT (%)	N/A
N/A	Flare Traversable LT?	N/A	N/A	Flare Traversable RT?	N/A
N/A	Landing Length (in)	N/A	N/A	DWS Provided?	N/A
N/A	Landing Width (in)	N/A	N/A	DWS Contrast?	N/A
N/A	Landing Slope (%)	N/A	N/A	DWS Length (in)	N/A
N/A	Landing X Slope (%)	N/A	N/A	DWS Full Width?	N/A
N/A	Landing Curb? (Y/N)	N/A	N/A	DWS Offset (in)	N/A
N/A	Shared Landing?	N/A			
N/A	Gutter Ponding?	N/A	N/A	Gutter Slope (%)	N/A
N/A	Gutter Lip Ht (in)	N/A	N/A	Gutter X Slope (%)	N/A
N/A	Painted X Walk1?	No	N/A	Painted X Walk2?	No
	X Walk 1 Direction	To S		X Walk 2 Direction	To E
N/A	X Walk 1 Width (in)	N/A	N/A	X Walk 2 Width (in)	N/A
	X Walk 1 Slope (%)	1.1		X Walk 2 Slope (%)	1.4
	X Walk 1 X Slope (%)	3.7		X Walk 2 X Slope (%)	5.0

N/A	Ramp inside XWalk1?	N/A	N/A	Ramp inside XWalk2?	N/A
	Road Slope (%)	2.3	N/A	Clear Space?	N/A
	Road X Slope (%)	4.9	N/A	Clear Space to XWalk (in)	N/A
N/A	Any Obstructions?	N/A	N/A	Storm Grate/Utility Hazard?	N/A
	Obstruction Type			Storm Grate/Utility Type	
		N/A			N/A
		Yes		Surface Condition? (G/P)	Good

**Remove & Replace Curb Ramp With Two New Directional Ramps or Equivalent.**
