Access Compliance Report

Public Rights-of-Way

(Curb Ramps)

Intersection ID: 11597	Main Street: E_20TH_ST	Cross Street: SEIGLE_AV	Location: S
ADA ID: BD0744DC5FFB	Ramp Type: BlendTrans1	Initial Pass/Fail: Fail	Overall Compliance: No
		Severity Score: 12.5

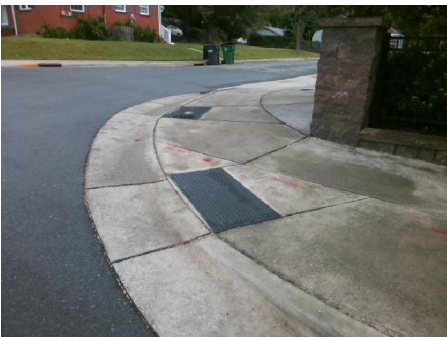
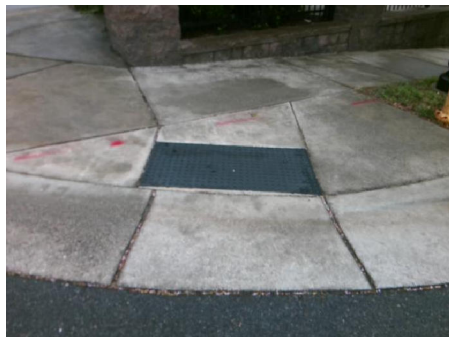
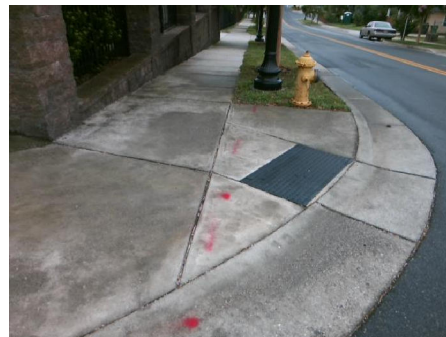
Not Found, R304.5.3

Compliance	Description	Data	Compliance	Description	Data
N/A	Ramp Length (in)	37.0	Yes	BlendTrans Slope (%)	1.1
Yes	Ramp Width (in)	48.0	No	BlendTrans XSlope (%)	6.9
N/A	Flare Type LT	N/A	N/A	Flare Type RT	N/A
N/A	Flare Slope LT (%)	N/A	N/A	Flare Slope RT (%)	N/A
N/A	Flare Traversable LT?	N/A	N/A	Flare Traversable RT?	N/A
N/A	Landing Length (in)	N/A	N/A	DWS Provided?	N/A
N/A	Landing Width (in)	N/A	N/A	DWS Contrast?	N/A
N/A	Landing Slope (%)	N/A	N/A	DWS Length (in)	N/A
N/A	Landing X Slope (%)	N/A	N/A	DWS Full Width?	N/A
N/A	Landing Curb? (Y/N)	N/A	N/A	DWS Offset (in)	N/A
N/A	Shared Landing?	N/A			
N/A	Gutter Ponding?	N/A	N/A	Gutter Slope (%)	N/A
N/A	Gutter Lip Ht (in)	N/A	N/A	Gutter X Slope (%)	N/A
N/A	Painted X Walk1?	No	N/A	Painted X Walk2?	N/A
	X Walk 1 Direction	To NW		X Walk 2 Direction	N/A
	X Walk 1 Width (in)	N/A		X Walk 2 Width (in)	N/A
	X Walk 1 Slope (%)	1.4		X Walk 2 Slope (%)	N/A
	X Walk 1 X Slope (%)	7.9		X Walk 2 X Slope (%)	N/A

N/A	Ramp inside XWalk1?	N/A	N/A	Ramp inside XWalk2?	N/A
	Road Slope (%)	7.9		Clear Space?	N/A
	Road X Slope (%)	1.4	N/A	Clear Space to XWalk (in)	N/A
N/A	Any Obstructions?	N/A	N/A	Storm Grate/Utility Hazard?	N/A
	Obstruction Type			Storm Grate/Utility Type	
		N/A			N/A
			Yes	Surface Condition? (G/P)	Good
			No	Curb Slope (%)	9.0

Remove & Replace Curb Ramp With Two New Directional Ramps or Equivalent.
