Access Compliance Report

Public Rights-of-Way (Curb Ramps)

Intersection ID: 45241	Main Street: TALUS_TRACE_LN	Cross Street: TALUS_TRACE_LN	Location: SW
ADA ID: BD0C48D7CB68	Ramp Type: PerpDiag	Initial Pass/Fail: Fail	Overall Compliance: No
Severity Score: 13.75			
Codes/Mitigation Info/Possible Solution		Field Measurements/Component Compliance

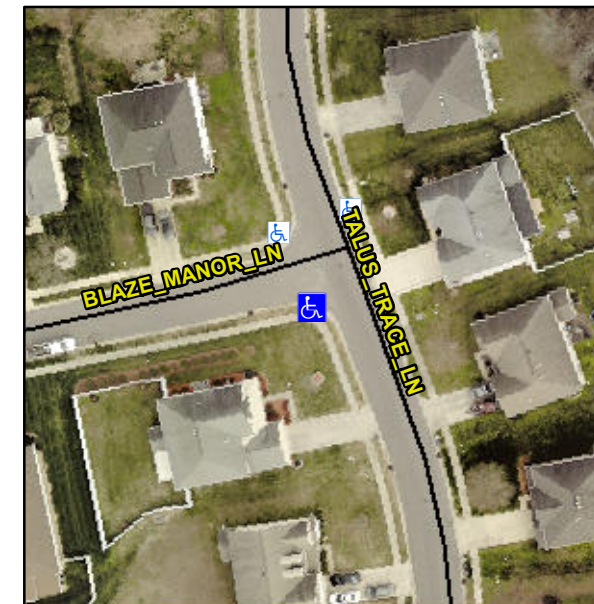
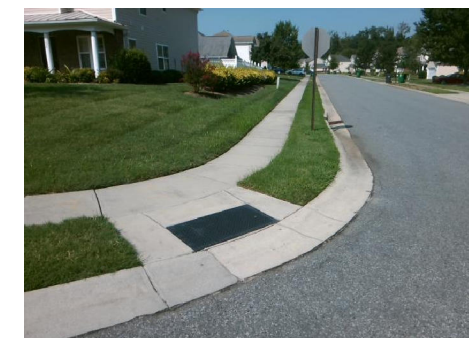
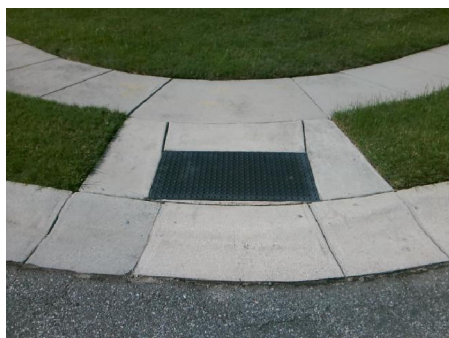
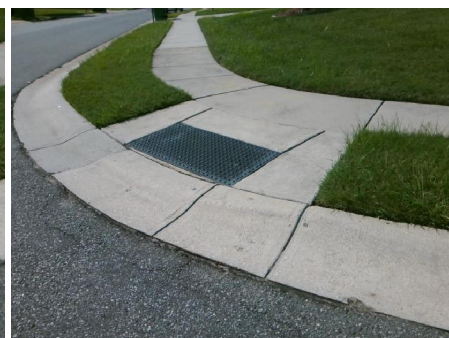
Not Found, R304.2.2, R304.5.3

Compliance	Description	Data	Compliance	Description	Data
N/A	Ramp Length (in)	45.5	No	Ramp Slope (%)	8.9
Yes	Ramp Width (in)	48.0	No	Ramp XSlope (%)	2.8
N/A	Flare Type LT	N/A	N/A	Flare Type RT	N/A
N/A	Flare Slope LT (%)	N/A	N/A	Flare Slope RT (%)	N/A
N/A	Flare Traversable LT?	N/A	N/A	Flare Traversable RT?	N/A
N/A	Landing Length (in)	N/A	N/A	DWS Provided?	N/A
N/A	Landing Width (in)	N/A	N/A	DWS Contrast?	N/A
N/A	Landing Slope (%)	N/A	N/A	DWS Length (in)	N/A
N/A	Landing X Slope (%)	N/A	N/A	DWS Full Width?	N/A
N/A	Landing Curb? (Y/N)	N/A	N/A	DWS Offset (in)	N/A
N/A	Shared Landing?	N/A			
N/A	Gutter Ponding?	N/A	N/A	Gutter Slope (%)	N/A
N/A	Gutter Lip Ht (in)	0.5	N/A	Gutter X Slope (%)	N/A
N/A	Painted X Walk1?	No	N/A	Painted X Walk2?	No
	X Walk 1 Direction	To E		X Walk 2 Direction	To N
N/A	X Walk 1 Width (in)	N/A	N/A	X Walk 2 Width (in)	N/A
	X Walk 1 Slope (%)	3.6		X Walk 2 Slope (%)	2.6
	X Walk 1 X Slope (%)	2.0		X Walk 2 X Slope (%)	0.6

N/A	Ramp inside XWalk1?	N/A	N/A	Ramp inside XWalk2?	N/A
	Road Slope (%)	2.2	N/A	Clear Space?	N/A
	Road X Slope (%)	1.9	N/A	Clear Space to XWalk (in)	N/A
N/A	Any Obstructions?	N/A	N/A	Storm Grate/Utility Hazard?	N/A
	Obstruction Type			Storm Grate/Utility Type	
		N/A			N/A
			Yes	Surface Condition? (G/P)	Good

Remove & Replace Curb Ramp With Two New Directional Ramps or Equivalent.
