Access Compliance Report Public Rights-of-Way (Curb Ramps)

Intersection ID: 42698 Main Street: OLD SARDIS RD **Cross Street: PROVIDENCE RD** Location: Ε **Overall Compliance: No Severity Score:** 12.5 **ADA ID: BD0CF7AEB35C** Ramp Type: PerpDiag Initial Pass/Fail: Fail

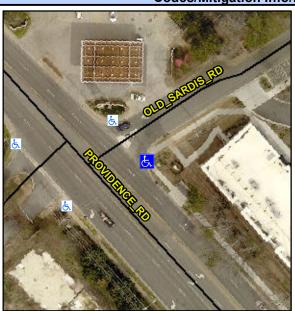
Total Cost: 3200.00 Compliance Description Data Compliance Description Data No Ramp Slope (%) N/A Ramp Length (in) 72.0 9.8 Yes Ramp XSlope (%) Yes Ramp Width (in) 48.0 0.2 N/A N/A Flare Type LT N/A Flare Type RT N/A N/A N/A N/A Flare Slope RT (%) N/A Flare Slope LT (%) N/A Flare Traversable LT? N/A N/A Flare Traversable RT? N/A N/A N/A N/A **DWS Provided?** N/A Landing Length (in) N/A Landing Width (in) N/A N/A **DWS Contrast?** N/A N/A N/A N/A Landing Slope (%) DWS Length (in) N/A N/A Landing X Slope (%) N/A N/A DWS Full Width? N/A N/A Landing Curb? (Y/N) N/A N/A DWS Offset (in) N/A N/A N/A Shared Landing? N/A **Gutter Ponding?** N/A N/A Gutter Slope (%) N/A N/A Gutter Lip Ht (in) N/A N/A Gutter X Slope (%) N/A N/A Painted X Walk1? No N/A Painted X Walk2? No X Walk 1 Direction To NW X Walk 2 Direction To SW N/A N/A N/A X Walk 1 Width (in) X Walk 2 Width (in) N/A X Walk 1 Slope (%) 1.5 X Walk 2 Slope (%) 0.3 X Walk 1 X Slope (%) 2.6 X Walk 2 X Slope (%) 8.0 N/A N/A N/A Ramp inside XWalk2? N/A Ramp inside XWalk1? Road Slope (%) 0.1 N/A Clear Space? N/A N/A Road X Slope (%) 3.3 Clear Space to XWalk (in) N/A N/A N/A N/A Any Obstructions? Storm Grate/Utility Hazard? N/A **Obstruction Type** Storm Grate/Utility Type N/A

OLD SARDIS RD StopSign **PROVIDENCE RD** None Possible Solutions: Remove & Replace Curb Ramp With Two New Directional Ramps or Equivalent. Surveyor Notes: N/A PROW/ADA: Not Found, R304.2.2
