# Access Compliance Report

## Public Rights-of-Way

### (Curb Ramps)

Intersection ID: 21577	Main Street: SARDIS_CROSSING_DR	Cross Street: GALLERIA_BV	Location: SE
ADA ID: BD1016B57594	Ramp Type: PerpDiag	Initial Pass/Fail: Fail	Overall Compliance: No
Severity Score: 33.75			
Codes/Mitigation Info/Possible Solution		Field Measurements/Component Compliance

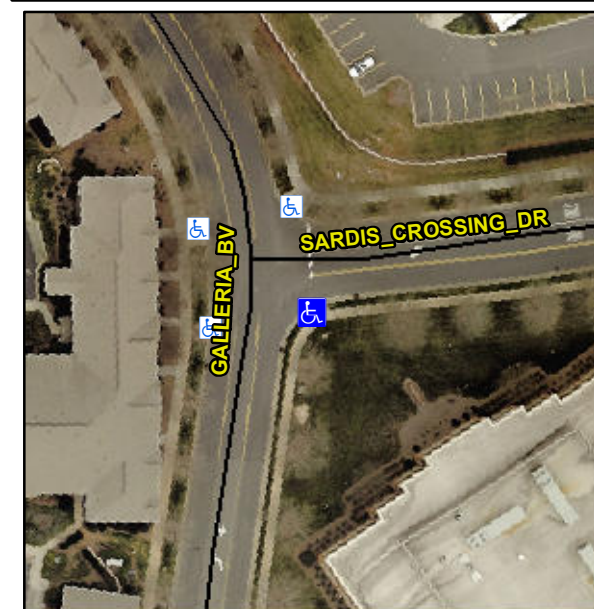
Compliance	Description	Data	Compliance	Description	Data
N/A	Ramp Length (in)	47.0	No	Ramp Slope (%)	8.7
No	Ramp Width (in)	40.0	No	Ramp XSlope (%)	5.4
N/A	Flare Type LT	N/A	N/A	Flare Type RT	N/A
N/A	Flare Slope LT (%)	N/A	N/A	Flare Slope RT (%)	N/A
N/A	Flare Traversable LT?	N/A	N/A	Flare Traversable RT?	N/A
N/A	Landing Length (in)	N/A	N/A	DWS Provided?	N/A
N/A	Landing Width (in)	N/A	N/A	DWS Contrast?	N/A
N/A	Landing Slope (%)	N/A	N/A	DWS Length (in)	N/A
N/A	Landing X Slope (%)	N/A	N/A	DWS Full Width?	N/A
N/A	Landing Curb? (Y/N)	N/A	N/A	DWS Offset (in)	N/A
N/A	Shared Landing?	N/A			
N/A	Gutter Ponding?	N/A	N/A	Gutter Slope (%)	N/A
N/A	Gutter Lip Ht (in)	N/A	N/A	Gutter X Slope (%)	N/A
N/A	Painted X Walk1?	No	N/A	Painted X Walk2?	No
	X Walk 1 Direction	To N		X Walk 2 Direction	To W
N/A	X Walk 1 Width (in)	N/A	N/A	X Walk 2 Width (in)	N/A
	X Walk 1 Slope (%)	0.5		X Walk 2 Slope (%)	4.5
	X Walk 1 X Slope (%)	2.4		X Walk 2 X Slope (%)	0.3

N/A	Ramp inside XWalk1?	N/A	N/A	Ramp inside XWalk2?	N/A
	Road Slope (%)	3.3	N/A	Clear Space?	N/A
	Road X Slope (%)	0.1	N/A	Clear Space to XWalk (in)	N/A
N/A	Any Obstructions?	N/A	N/A	Storm Grate/Utility Hazard?	N/A
	Obstruction Type			Storm Grate/Utility Type	
		N/A			N/A
			Yes	Surface Condition? (G/P)	Good

**Remove & Replace Curb Ramp With Two New Directional Ramps or Equivalent.**

**R304.5.1, R304.2.2, R304.5.3**

Total Cost: \$ 3200.00
