Access Compliance Report Public Rights-of-Way (Curb Ramps)

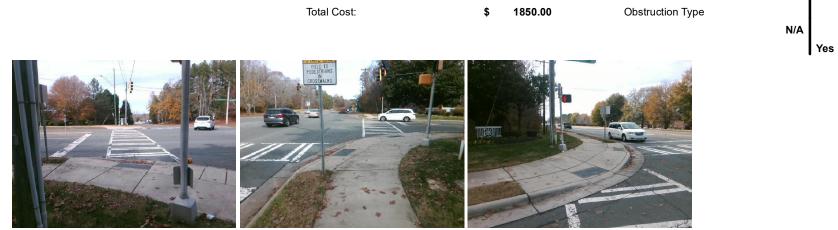
Interpotion ID: 24025	Main Str		Croop Street				Location	
Intersection ID: 24035	Main Street: ECHO_FOREST_DR		Cross Street: PINEVILLE-MATTHEWS_RD			Location:	S	
ADA ID: BD1715DA33AB	ID: BD1715DA33AB Ramp Type: Perp		Initial Pass/Fail: Fail Overall Compliance: N			ce: N	o Severity Score:	12.5
Codes/Mitigation Info/Possible Solution			Field Measurements/Component Compliance					
		Possible Solutions:	Compliance Description		Data	Data Compliance Description		Data
		Remove & Replace Entire Ramp.	N/A	Ramp Length (in)	112.0	No	Ramp Slope (%)	8.7
	1 1 1 2		Yes	Ramp Width (in)	48.0	Yes	Ramp XSlope (%)	1.6
FE YS' / SI	and the second		N/A	Flare Type LT	N/A	N/A	Flare Type RT	N/A

6. 6. 6. 6. 6. 6. 6. 6. 6. 6. 6. 6. 6. 6			N/A	Flare Slope LT (%)	N/A	N/A	Flare Slope RT (%)	N/A
			N/A	Flare Traversable LT?	N/A	N/A	Flare Traversable RT?	N/A
			N/A	Landing Length (in)	N/A	N/A	DWS Provided?	N/A
	10 A	Surveyor Notes:	N/A	Landing Width (in)	N/A	N/A	DWS Contrast?	N/A
		N/A	N/A	Landing Slope (%)	N/A	N/A	DWS Length (in)	N/A
			N/A	Landing X Slope (%)	N/A	N/A	DWS Full Width?	N/A
			N/A	Landing Curb? (Y/N)	N/A	N/A	DWS Offset (in)	N/A
			N/A	Shared Landing?	N/A			
		PROW/ADA:	N/A	Gutter Ponding?	N/A	N/A	Gutter Slope (%)	N/A
		Not Found, R304.2.2	N/A	Gutter Lip Ht (in)	N/A	N/A	Gutter X Slope (%)	N/A
Maria Maria Maria	A A A	· ·	N/A	Painted X Walk1?	Yes	N/A	Painted X Walk2?	N/A
12/2 Mar and Alex			X Walk 1 Direction	To NW		X Walk 2 Direction	N/A	
A CALLER AND A CAL			N/A	X Walk 1 Width (in)	108.0	N/A	X Walk 2 Width (in)	N/A
Street 1 Name PINEVI	LLE-MATTHEWS RD			X Walk 1 Slope (%)	3.3		X Walk 2 Slope (%)	N/A

Stop Condition-Street 2	Signal			X Walk 1 X Slope (%)	2.7		X Walk 2 X Slope (%)	N/A
Street 2 Name	N/A		N/A	Ramp inside XWalk1?	Yes	N/A	Ramp inside XWalk2?	N/A
Stop Condition-Street 1	N/A			Road Slope (%)	N/A	N/A	Clear Space?	N/A
				Road X Slope (%)	N/A	N/A	Clear Space to XWalk (in)	N/A
			N/A	Any Obstructions?	N/A	N/A	Storm Grate/Utility Hazard?	N/A
		Total Cost: \$ 1	850.00	Obstruction Type			Storm Grate/Utility Type	
					N/A			N/A
4
