Access Compliance Report

Public Rights-of-Way

(Curb Ramps)

| Intersection ID: 53224 | Main Street: URBAN_PL | Cross Street: GIVENS_WY | Location: NE |

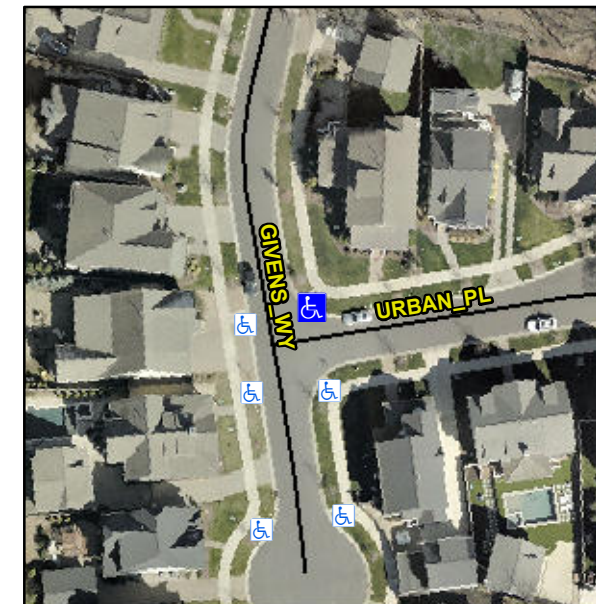
Not Found, R304.5.1, R304.2.2

| Compliance | Description | Data | Compliance | Description | Data |
|---|---|---|---|---|---|
| N/A | Ramp Length (in) | 94.5 | No | Ramp Slope (%) | 9.1 |
| No | Ramp Width (in) | 45.0 | Yes | Ramp XSlope (%) | 1.7 |

Remove & Replace Curb Ramp With Two New Directional Ramps or Equivalent.
