# Access Compliance Report

## Public Rights-of-Way

### (Curb Ramps)

Intersection ID: 18891	Main Street: FLAGSTAFF_DR	Cross Street: TYVOLA_RD	Location: SE
ADA ID: BD2C8A0828F7	Ramp Type: PerpDiag	Initial Pass/Fail: Fail	Overall Compliance: No
		Severity Score: 22.5

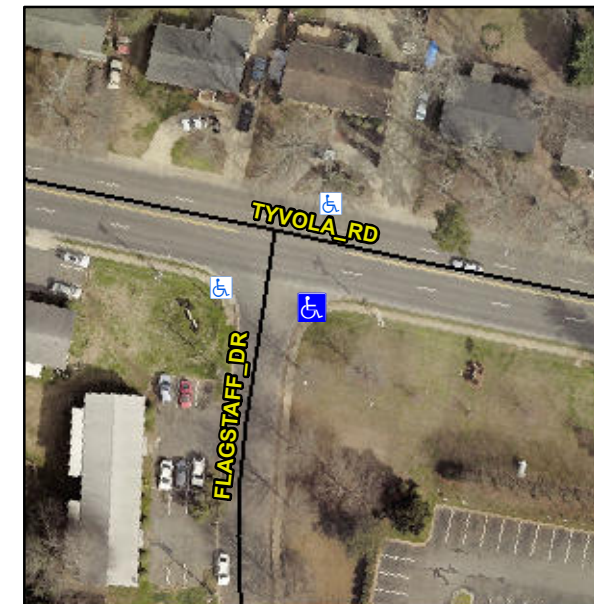
**Not Found, R304.5.1, R304.2.2, R304.5.3**

Compliance	Description	Data	Compliance	Description	Data
N/A	Ramp Length (in)	66.0	No	Ramp Slope (%)	10.9
No	Ramp Width (in)	41.0	No	Ramp XSlope (%)	4.5
N/A	Flare Type LT	N/A	N/A	Flare Type RT	N/A
N/A	Flare Slope LT (%)	N/A	N/A	Flare Slope RT (%)	N/A
N/A	Flare Traversable LT?	N/A	N/A	Flare Traversable RT?	N/A
N/A	Landing Length (in)	N/A	N/A	DWS Provided?	N/A
N/A	Landing Width (in)	N/A	N/A	DWS Contrast?	N/A
N/A	Landing Slope (%)	N/A	N/A	DWS Length (in)	N/A
N/A	Landing X Slope (%)	N/A	N/A	DWS Full Width?	N/A
N/A	Landing Curb? (Y/N)	N/A	N/A	DWS Offset (in)	N/A
N/A	Shared Landing?	N/A			
N/A	Gutter Ponding?	N/A	N/A	Gutter Slope (%)	N/A
N/A	Gutter Lip Ht (in)	N/A	N/A	Gutter X Slope (%)	N/A
N/A	Painted X Walk1?	No	N/A	Painted X Walk2?	No
	X Walk 1 Direction	To NE		X Walk 2 Direction	To NW
N/A	X Walk 1 Width (in)	N/A	N/A	X Walk 2 Width (in)	N/A
	X Walk 1 Slope (%)	6.4		X Walk 2 Slope (%)	2.2
	X Walk 1 X Slope (%)	0.5		X Walk 2 X Slope (%)	6.0

N/A	Ramp inside XWalk1?	N/A	N/A	Ramp inside XWalk2?	N/A
	Road Slope (%)	3.8	N/A	Clear Space?	N/A
	Road X Slope (%)	4.9	N/A	Clear Space to XWalk (in)	N/A
N/A	Any Obstructions?	N/A	N/A	Storm Grate/Utility Hazard?	N/A
	Obstruction Type			Storm Grate/Utility Type	
		N/A			N/A
			Yes	Surface Condition? (G/P)	Good

**Remove & Replace Curb Ramp With Two New Directional Ramps or Equivalent.**
