Access Compliance Report

Public Rights-of-Way

(Curb Ramps)

Intersection ID: 15074	Main Street: MAGNOLIA_AV	Cross Street: PARK_RD	Location: SW
ADA ID: BD2CC5A8CFB3	Ramp Type: Perp	Initial Pass/Fail: Fail	Overall Compliance: No
		Severity Score: 1.25

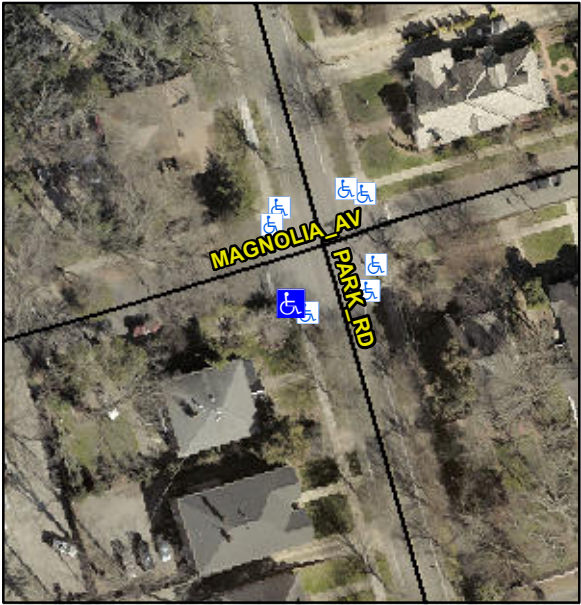
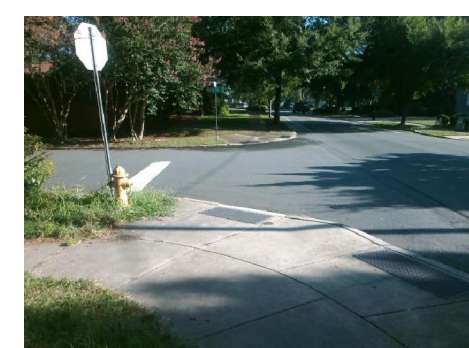
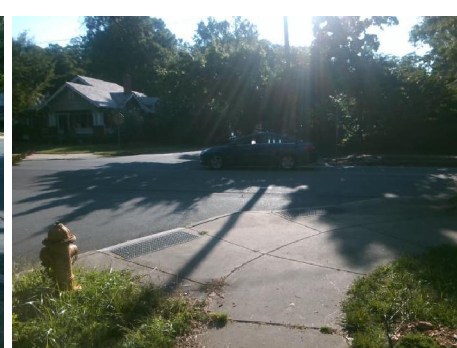
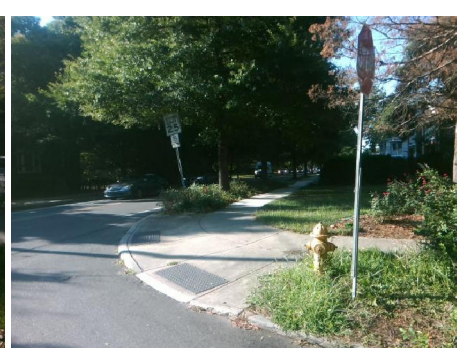
Possible Solutions:		Compliance	Description	Data
	Remove & Replace Entire Ramp.		Yes	Ramp Length (in)	138.0
			No	Ramp Width (in)	48.0
			N/A	Flare Type LT	N/A
			N/A	Flare Slope LT (%)	N/A
			N/A	Flare Traversable LT?	N/A
			N/A	Landing Length (in)	N/A
			N/A	Landing Width (in)	N/A
			N/A	Landing Slope (%)	N/A
			N/A	Landing X Slope (%)	N/A
<p>Surveyor Notes:</p> <p>N/A</p> <p>PROW/ADA:</p> <p>Not Found, R304.5.3</p>			N/A	Flare Type RT	N/A
			N/A	Flare Slope RT (%)	N/A
			N/A	Flare Traversable RT?	N/A
			N/A	DWS Provided?	N/A
			N/A	DWS Contrast?	N/A
			N/A	DWS Length (in)	N/A
			N/A	DWS Full Width?	N/A
			N/A	DWS Offset (in)	N/A
			N/A	Gutter Ponding?	N/A
			N/A	Gutter Lip Ht (in)	N/A
			No	Painted X Walk1?	N/A
			To N	X Walk 1 Direction	N/A
			N/A	X Walk 1 Width (in)	N/A

3.5	X Walk 1 Slope (%)	N/A
			3.6	X Walk 1 X Slope (%)	N/A
			N/A	Ramp inside XWalk1?	N/A
			N/A	Road Slope (%)	N/A
			N/A	Road X Slope (%)	N/A
			N/A	Any Obstructions?	N/A
				Obstruction Type	N/A
Total Cost:		\$ 1850.00	N/A	Storm Grate/Utility Hazard?	N/A
			N/A	Storm Grate/Utility Type	N/A
			Yes	Surface Condition? (G/P)	Good
