# Access Compliance Report

## Public Rights-of-Way

Intersection ID: 14252	Main Street: BAXTER_ST	Cross Street: CECIL_ST	Location: NE
ADA ID: BD2EBF4C2FDF	Ramp Type: PerpDiag	Initial Pass/Fail: Fail	Overall Compliance: No
Severity Score: 13.75			
Codes/Mitigation Info/Possible Solution		Field Measurements/Component Compliance

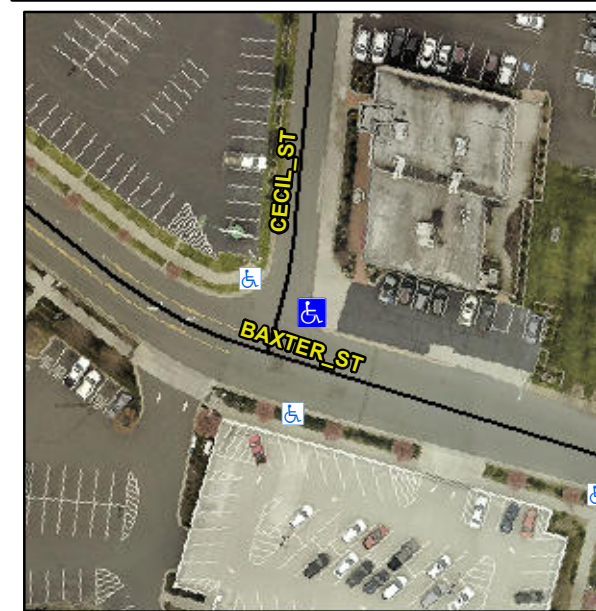
**Not Found, R304.2.2, R304.5.3**

Compliance	Description	Data	Compliance	Description	Data
N/A	Ramp Length (in)	41.0	No	Ramp Slope (%)	9.3
Yes	Ramp Width (in)	48.0	No	Ramp XSlope (%)	2.5
N/A	Flare Type LT	N/A	N/A	Flare Type RT	N/A
N/A	Flare Slope LT (%)	N/A	N/A	Flare Slope RT (%)	N/A
N/A	Flare Traversable LT?	N/A	N/A	Flare Traversable RT?	N/A
N/A	Landing Length (in)	N/A	N/A	DWS Provided?	N/A
N/A	Landing Width (in)	N/A	N/A	DWS Contrast?	N/A
N/A	Landing Slope (%)	N/A	N/A	DWS Length (in)	N/A
N/A	Landing X Slope (%)	N/A	N/A	DWS Full Width?	N/A
N/A	Landing Curb? (Y/N)	N/A	N/A	DWS Offset (in)	N/A
N/A	Shared Landing?	N/A			
N/A	Gutter Ponding?	N/A	N/A	Gutter Slope (%)	N/A
N/A	Gutter Lip Ht (in)	N/A	N/A	Gutter X Slope (%)	N/A
N/A	Painted X Walk1?	No	N/A	Painted X Walk2?	No
	X Walk 1 Direction	To NW		X Walk 2 Direction	To SW
N/A	X Walk 1 Width (in)	N/A	N/A	X Walk 2 Width (in)	N/A
	X Walk 1 Slope (%)	3.1		X Walk 2 Slope (%)	4.8
	X Walk 1 X Slope (%)	2.5		X Walk 2 X Slope (%)	2.3

N/A	Ramp inside XWalk1?	N/A	N/A	Ramp inside XWalk2?	N/A
	Road Slope (%)	2.1	N/A	Clear Space?	N/A
	Road X Slope (%)	1.7	N/A	Clear Space to XWalk (in)	N/A
N/A	Any Obstructions?	N/A	N/A	Storm Grate/Utility Hazard?	N/A
	Obstruction Type			Storm Grate/Utility Type	
		N/A			N/A
		Yes		Surface Condition? (G/P)	Good

**Remove & Replace Curb Ramp With Two New Directional Ramps or Equivalent.**

Total Cost: \$ 3200.00
