# Access Compliance Report

## Public Rights-of-Way

### (Curb Ramps)

Intersection ID: N/A	Main Street: REA_RD	Cross Street: CEDAR_CROFT_DR	Location: E
ADA ID: BD4D5C98673D	Ramp Type: PerpDiag	Initial Pass/Fail: Fail	Overall Compliance: No
Severity Score: 37.5			
Codes/Mitigation Info/Possible Solution		Field Measurements/Component Compliance

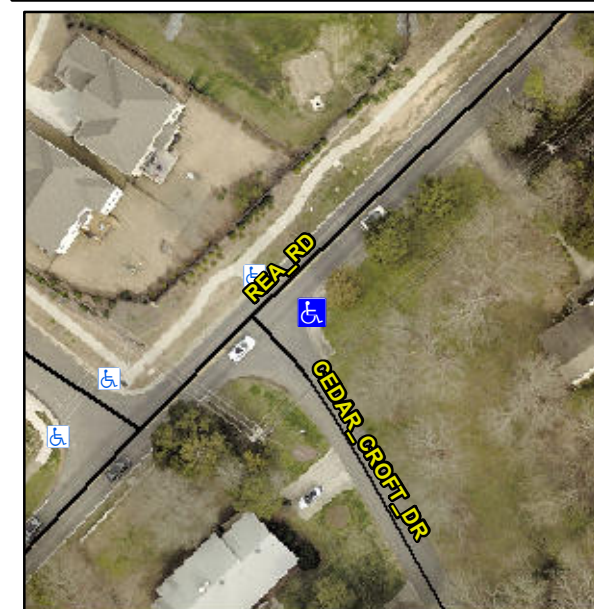
**Not Found, R304.2.2, R304.5.3**

Compliance	Description	Data	Compliance	Description	Data
N/A	Ramp Length (in)	62.0	No	Ramp Slope (%)	11.9
Yes	Ramp Width (in)	48.0	No	Ramp XSlope (%)	10.4
N/A	Flare Type LT	N/A	N/A	Flare Type RT	N/A
N/A	Flare Slope LT (%)	N/A	N/A	Flare Slope RT (%)	N/A
N/A	Flare Traversable LT?	N/A	N/A	Flare Traversable RT?	N/A
N/A	Landing Length (in)	N/A	N/A	DWS Provided?	N/A
N/A	Landing Width (in)	N/A	N/A	DWS Contrast?	N/A
N/A	Landing Slope (%)	N/A	N/A	DWS Length (in)	N/A
N/A	Landing X Slope (%)	N/A	N/A	DWS Full Width?	N/A
N/A	Landing Curb? (Y/N)	N/A	N/A	DWS Offset (in)	N/A
N/A	Shared Landing?	N/A			
N/A	Gutter Ponding?	N/A	N/A	Gutter Slope (%)	N/A
N/A	Gutter Lip Ht (in)	N/A	N/A	Gutter X Slope (%)	N/A
N/A	Painted X Walk1?	No	N/A	Painted X Walk2?	No
	X Walk 1 Direction	To NW		X Walk 2 Direction	To SW
N/A	X Walk 1 Width (in)	N/A	N/A	X Walk 2 Width (in)	N/A
	X Walk 1 Slope (%)	10.1		X Walk 2 Slope (%)	0.2
	X Walk 1 X Slope (%)	3.0		X Walk 2 X Slope (%)	8.9

N/A	Ramp inside XWalk1?	N/A	N/A	Ramp inside XWalk2?	N/A
	Road Slope (%)	5.2	N/A	Clear Space?	N/A
	Road X Slope (%)	4.4	N/A	Clear Space to XWalk (in)	N/A
N/A	Any Obstructions?	N/A	N/A	Storm Grate/Utility Hazard?	N/A
	Obstruction Type			Storm Grate/Utility Type	
		N/A			N/A
			Yes	Surface Condition? (G/P)	Good

**Remove & Replace Curb Ramp With Two New Directional Ramps or Equivalent.**

Total Cost: \$ 3200.00
