Access Compliance Report Public Rights-of-Way (Curb Ramps)

Intersection ID: N/A Main Street: W_W_T_HARRIS_BV Cross Street: N/A Location:

ADA ID: BD5AFB7CFF67 Ramp Type: IslandPerp Initial Pass/Fail: Fail Overall Compliance: No Severity Score: 13.75

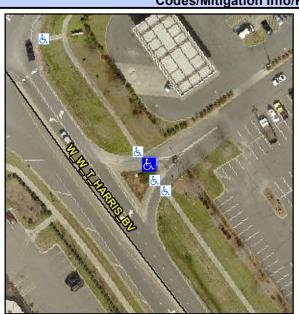
Not Found, R304.2.2

Tiola inducation of the principal and						
	Compliance Description		Data	Compliance Description		Data
	N/A	Ramp Length (in)	68.5	No	Ramp Slope (%)	8.7
	Yes	Ramp Width (in)	68.0	Yes	Ramp XSlope (%)	5.0
	N/A	Flare Type LT	N/A	N/A	Flare Type RT	N/A
	N/A	Flare Slope LT (%)	N/A	N/A	Flare Slope RT (%)	N/A
	N/A	Flare Traversable LT?	N/A	N/A	Flare Traversable RT?	N/A
	N/A	Landing Length (in)	N/A	N/A	DWS Provided?	N/A
	N/A	Landing Width (in)	N/A	N/A	DWS Contrast?	N/A
	N/A	Landing Slope (%)	N/A	N/A	DWS Length (in)	N/A
	N/A	Landing X Slope (%)	N/A	N/A	DWS Full Width?	N/A
	N/A	Landing Curb? (Y/N)	N/A	N/A	DWS Offset (in)	N/A
	N/A	Shared Landing?	N/A			
	N/A	Gutter Ponding?	N/A	N/A	Gutter Slope (%)	N/A
	N/A	Gutter Lip Ht (in)	N/A	N/A	Gutter X Slope (%)	N/A
	N/A	Painted X Walk1?	No	N/A	Painted X Walk2?	N/A
		X Walk 1 Direction	To N		X Walk 2 Direction	N/A
	N/A	X Walk 1 Width (in)	N/A	N/A	X Walk 2 Width (in)	N/A
		X Walk 1 Slope (%)	0.1		X Walk 2 Slope (%)	N/A

X Walk 1 X Slope (%)	5.7		X Walk 2 X Slope (%)	N/A
	N/A	Ramp inside XWalk1?	N/A	N/A	Ramp inside XWalk2?	N/A
		Road Slope (%)	N/A	N/A	Clear Space?	N/A
		Road X Slope (%)	N/A	N/A	Clear Space to XWalk (in)	N/A
				l

Remove & Replace Entire Ramp.

Total Cost: \$ 3400.00
