Access Compliance Report

Public Rights-of-Way

(Curb Ramps)

Intersection ID: 10024261	Main Street: CRAIG_AV	Cross Street: N/A	Location: NW
ADA ID: BD5D5ACCC441	Ramp Type: PerpDiag	Initial Pass/Fail: Fail	Overall Compliance: No
Severity Score: 21.25			
Codes/Mitigation Info/Possible Solution		Field Measurements/Component Compliance

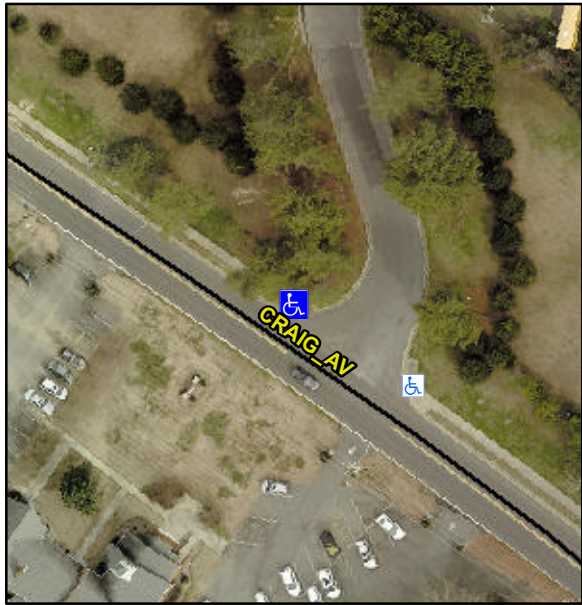
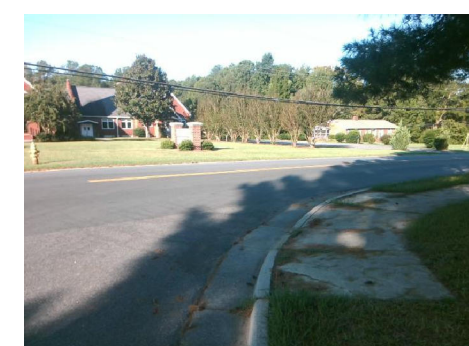
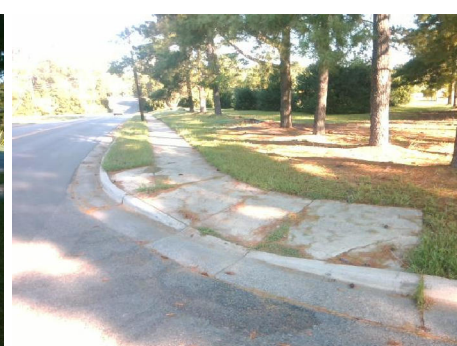
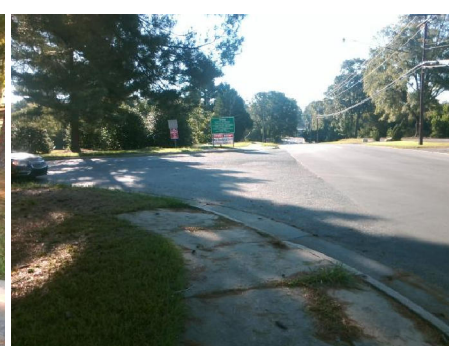
Compliance	Description	Data	Compliance	Description	Data
N/A	Ramp Length (in)	72.0	No	Ramp Slope (%)	8.9
No	Ramp Width (in)	39.0	Yes	Ramp XSlope (%)	0.5
N/A	Flare Type LT	N/A	N/A	Flare Type RT	N/A
N/A	Flare Slope LT (%)	N/A	N/A	Flare Slope RT (%)	N/A
N/A	Flare Traversable LT?	N/A	N/A	Flare Traversable RT?	N/A
N/A	Landing Length (in)	N/A	N/A	DWS Provided?	N/A
N/A	Landing Width (in)	N/A	N/A	DWS Contrast?	N/A
N/A	Landing Slope (%)	N/A	N/A	DWS Length (in)	N/A
N/A	Landing X Slope (%)	N/A	N/A	DWS Full Width?	N/A
N/A	Landing Curb? (Y/N)	N/A	N/A	DWS Offset (in)	N/A
N/A	Shared Landing?	N/A			
N/A	Gutter Ponding?	N/A	N/A	Gutter Slope (%)	N/A
N/A	Gutter Lip Ht (in)	N/A	N/A	Gutter X Slope (%)	N/A
N/A	Painted X Walk1?	No	N/A	Painted X Walk2?	No
	X Walk 1 Direction	To SW		X Walk 2 Direction	To SE
N/A	X Walk 1 Width (in)	N/A	N/A	X Walk 2 Width (in)	N/A
	X Walk 1 Slope (%)	2.5		X Walk 2 Slope (%)	2.8
	X Walk 1 X Slope (%)	2.9		X Walk 2 X Slope (%)	3.9

N/A	Ramp inside XWalk1?	N/A	N/A	Ramp inside XWalk2?	N/A
	Road Slope (%)	0.2	N/A	Clear Space?	N/A
	Road X Slope (%)	4.2	N/A	Clear Space to XWalk (in)	N/A
N/A	Any Obstructions?	N/A	N/A	Storm Grate/Utility Hazard?	N/A
	Obstruction Type			Storm Grate/Utility Type	
		N/A			N/A
			Yes	Surface Condition? (G/P)	Good

Possible Solutions:

Remove & Replace Curb Ramp With Two New Directional Ramps or Equivalent.
