Access Compliance Report

Public Rights-of-Way

(Curb Ramps)

| Intersection ID: 24524 | Main Street: CELBRIDGE_CT | Cross Street: SAINTFIELD_PL | Location: SW |

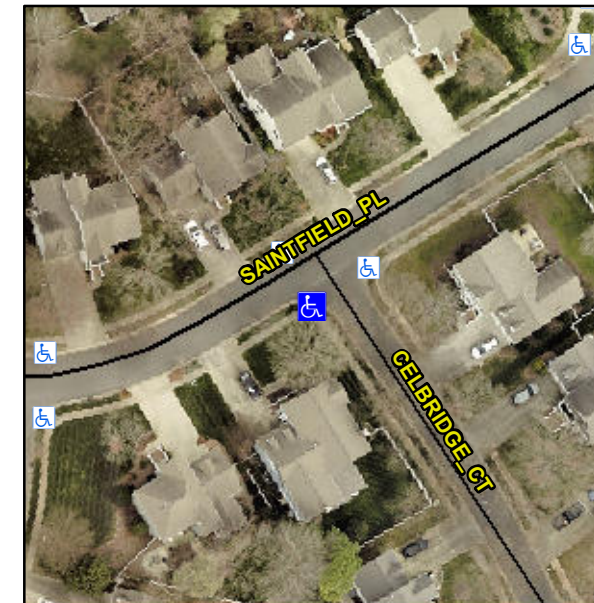
| ADA ID: BD5EF3951B0F | Ramp Type: PerpDiag | Initial Pass/Fail: Fail | Overall Compliance: No |

Not Found, R304.5.1, R304.5.3

| Compliance | Description | Data | Compliance | Description | Data |
|---|---|---|---|---|---|
| N/A | Ramp Length (in) | 48.0 | Yes | Ramp Slope (%) | 5.9 |
| No | Ramp Width (in) | 47.5 | No | Ramp XSlope (%) | 3.3 |

Remove & Replace Curb Ramp With Two New Directional Ramps or Equivalent.
