# Access Compliance Report

## Public Rights-of-Way

| Intersection ID: 17141 | Main Street: PARK_RD | Cross Street: WYNDCROFTE_PL | Location: NE |
| ADA ID: BD5FAEDF77B8 | Ramp Type: PerpDiag | Initial Pass/Fail: Fail | Overall Compliance: No |

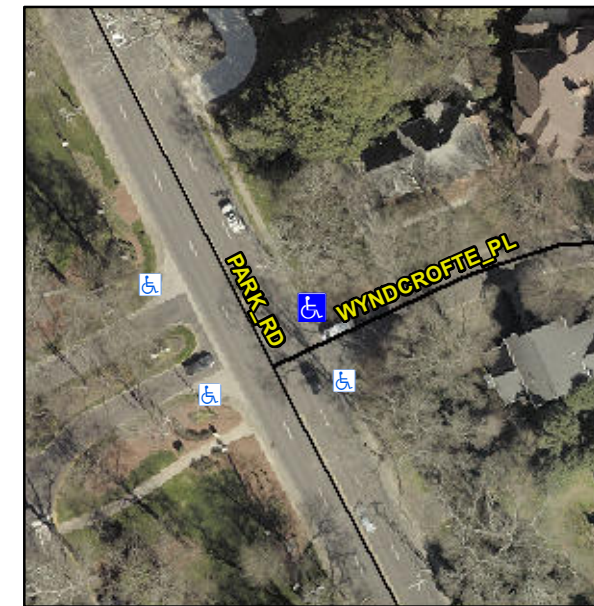
**Not Found, R304.5.1, R304.2.2**

| Compliance | Description | Data | Compliance | Description | Data |
|---|---|---|---|---|---|
| N/A | Ramp Length (in) | 48.0 | No | Ramp Slope (%) | 9.7 |
| No | Ramp Width (in) | 34.5 | Yes | Ramp XSlope (%) | 1.2 |

**Remove & Replace Curb Ramp With Two New Directional Ramps or Equivalent.**
