## Access Compliance Report Public Rights-of-Way (Curb Ramps)

Intersection ID: 18177 Main Street: OLD\_PINEVILLE\_RD Cross Street: SCHOLTZ\_RD Location: SW

ADA ID: BD70ABEE9346 Ramp Type: PerpDiag Initial Pass/Fail: Fail Overall Compliance: No Severity Score: 33.75

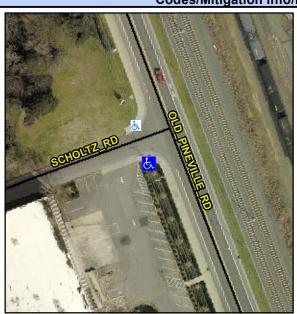
rieid Measurements/Component Compilance					
Compliance Description		Data	Comp	oliance Description	Data
N/A	Ramp Length (in)	74.0	Yes	Ramp Slope (%)	5.1
No	Ramp Width (in)	46.0	No	Ramp XSlope (%)	13.8
N/A	Flare Type LT	N/A	N/A	Flare Type RT	N/A
N/A	Flare Slope LT (%)	N/A	N/A	Flare Slope RT (%)	N/A
N/A	Flare Traversable LT?	N/A	N/A	Flare Traversable RT?	N/A
N/A	Landing Length (in)	N/A	N/A	DWS Provided?	N/A
N/A	Landing Width (in)	N/A	N/A	DWS Contrast?	N/A
N/A	Landing Slope (%)	N/A	N/A	DWS Length (in)	N/A
N/A	Landing X Slope (%)	N/A	N/A	DWS Full Width?	N/A
N/A	Landing Curb? (Y/N)	N/A	N/A	DWS Offset (in)	N/A
N/A	Shared Landing?	N/A			
N/A	Gutter Ponding?	N/A	N/A	Gutter Slope (%)	N/A
N/A	Gutter Lip Ht (in)	N/A	N/A	Gutter X Slope (%)	N/A
N/A	Painted X Walk1?	No	N/A	Painted X Walk2?	No
	X Walk 1 Direction	To E		X Walk 2 Direction	To N
N/A	X Walk 1 Width (in)	N/A	N/A	X Walk 2 Width (in)	N/A
	X Walk 1 Slope (%)	10.9		X Walk 2 Slope (%)	4.2

X Walk 1 X Slope (%)	2.8		X Walk 2 X Slope (%)	9.8
N/A	Ramp inside XWalk1?	N/A	N/A	Ramp inside XWalk2?	N/A
	Road Slope (%)	8.2	N/A	Clear Space?	N/A
	Road X Slope (%)	6.8	N/A	Clear Space to XWalk (in)	N/A
N/A	Any Obstructions?	N/A	N/A	Storm Grate/Utility Hazard?	N/A
	Obstruction Type			Storm Grate/Utility Type	
		N/A			N/A
			Yes	Surface Condition? (G/P)	Good

Remove & Replace Curb Ramp With Two New Directional Ramps or Equivalent.

R304.5.1, R304.5.3
