# Access Compliance Report

## Public Rights-of-Way

### (Curb Ramps)

Intersection ID: 17788	Main Street: BARWICK_RD	Cross Street: N_SHARON_AMITY_RD	Location: NW
ADA ID: BD7115C37D1D	Ramp Type: PerpDiag	Initial Pass/Fail: Fail	Overall Compliance: No
Severity Score: 43.75			
Codes/Mitigation Info/Possible Solution		Field Measurements/Component Compliance

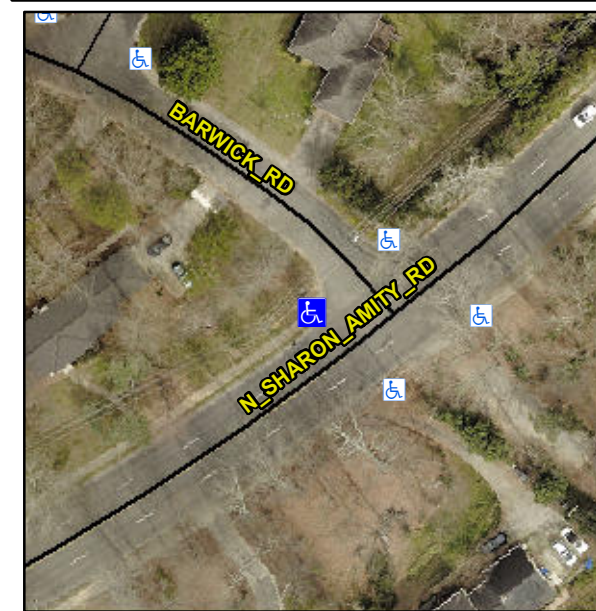
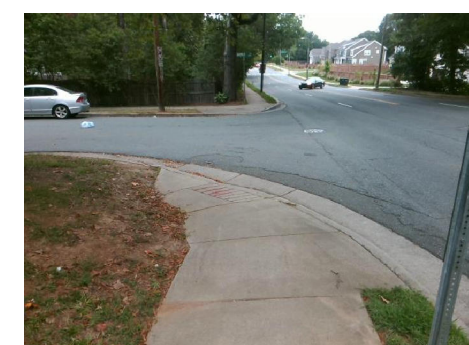
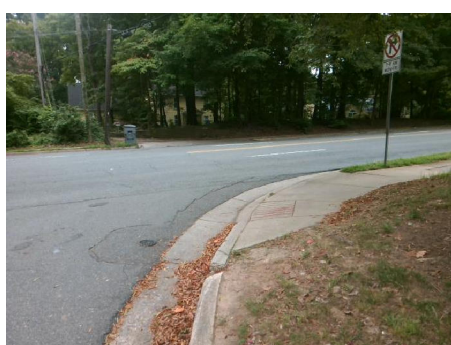
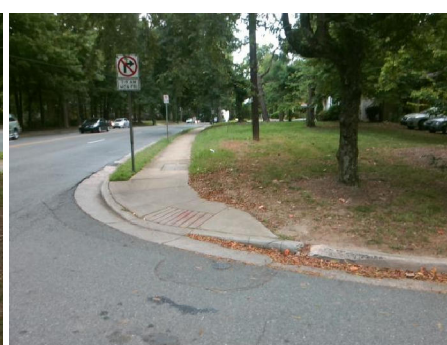
**Not Found, R304.5.1, R304.2.2, R304.5.3**

Compliance	Description	Data	Compliance	Description	Data
N/A	Ramp Length (in)	54.0	No	Ramp Slope (%)	15.8
No	Ramp Width (in)	34.0	No	Ramp XSlope (%)	2.4
N/A	Flare Type LT	N/A	N/A	Flare Type RT	N/A
N/A	Flare Slope LT (%)	N/A	N/A	Flare Slope RT (%)	N/A
N/A	Flare Traversable LT?	N/A	N/A	Flare Traversable RT?	N/A
N/A	Landing Length (in)	N/A	N/A	DWS Provided?	N/A
N/A	Landing Width (in)	N/A	N/A	DWS Contrast?	N/A
N/A	Landing Slope (%)	N/A	N/A	DWS Length (in)	N/A
N/A	Landing X Slope (%)	N/A	N/A	DWS Full Width?	N/A
N/A	Landing Curb? (Y/N)	N/A	N/A	DWS Offset (in)	N/A
N/A	Shared Landing?	N/A			
N/A	Gutter Ponding?	N/A	N/A	Gutter Slope (%)	N/A
N/A	Gutter Lip Ht (in)	N/A	N/A	Gutter X Slope (%)	N/A
N/A	Painted X Walk1?	No	N/A	Painted X Walk2?	No
	X Walk 1 Direction	To SE		X Walk 2 Direction	To NE
N/A	X Walk 1 Width (in)	N/A	N/A	X Walk 2 Width (in)	N/A
	X Walk 1 Slope (%)	4.2		X Walk 2 Slope (%)	2.7
	X Walk 1 X Slope (%)	2.5		X Walk 2 X Slope (%)	4.1

N/A	Ramp inside XWalk1?	N/A	N/A	Ramp inside XWalk2?	N/A
	Road Slope (%)	5.1	N/A	Clear Space?	N/A
	Road X Slope (%)	1.6	N/A	Clear Space to XWalk (in)	N/A
N/A	Any Obstructions?	N/A	N/A	Storm Grate/Utility Hazard?	N/A
	Obstruction Type			Storm Grate/Utility Type	
		N/A			N/A
			Yes	Surface Condition? (G/P)	Good

**Remove & Replace Curb Ramp With Two New Directional Ramps or Equivalent.**

Total Cost: \$ 3200.00
