# Access Compliance Report

## Public Rights-of-Way

### (Curb Ramps)

Intersection ID: 26458	Main Street: BRECHIN_DR	Cross Street: BROADFORD_CT	Location: NW
ADA ID: BD78BA9F31CC	Ramp Type: Perp	Initial Pass/Fail: Fail	Overall Compliance: No
Codes/Mitigation Info/Possible Solution		Field Measurements/Component Compliance	
Severity Score: 48.75

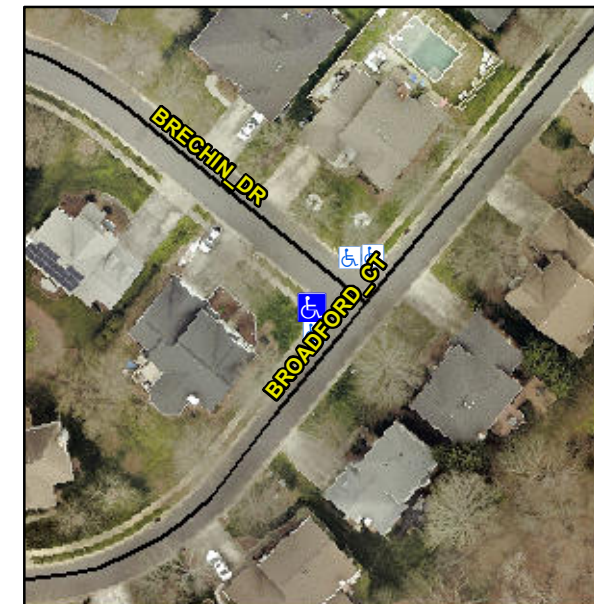
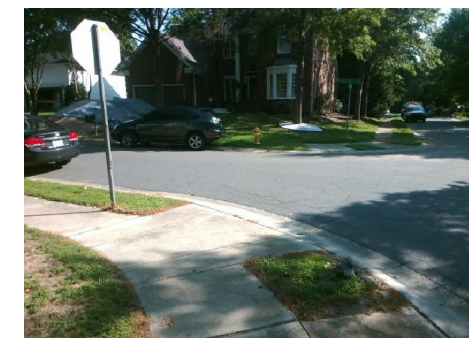
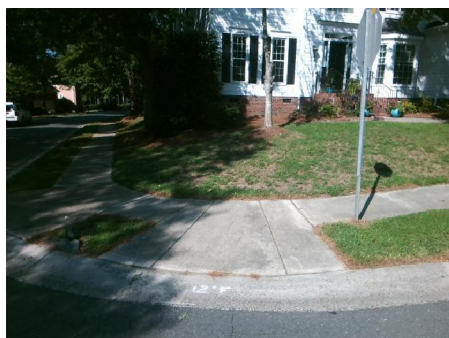
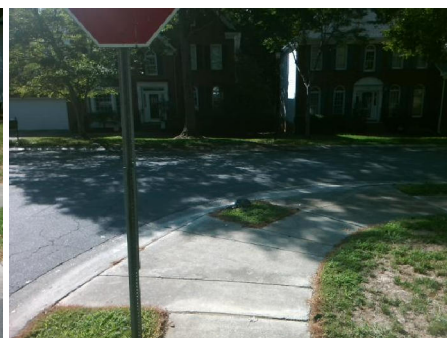
**Not Found, R304.5.1, R304.2.2, R304.5.3**

Compliance	Description	Data	Compliance	Description	Data
N/A	Ramp Length (in)	93.0	No	Ramp Slope (%)	8.5
No	Ramp Width (in)	30.0	No	Ramp XSlope (%)	4.6
N/A	Flare Type LT	N/A	N/A	Flare Type RT	N/A
N/A	Flare Slope LT (%)	N/A	N/A	Flare Slope RT (%)	N/A
N/A	Flare Traversable LT?	N/A	N/A	Flare Traversable RT?	N/A
N/A	Landing Length (in)	N/A	N/A	DWS Provided?	N/A
N/A	Landing Width (in)	N/A	N/A	DWS Contrast?	N/A
N/A	Landing Slope (%)	N/A	N/A	DWS Length (in)	N/A
N/A	Landing X Slope (%)	N/A	N/A	DWS Full Width?	N/A
N/A	Landing Curb? (Y/N)	N/A	N/A	DWS Offset (in)	N/A
N/A	Shared Landing?	N/A			
N/A	Gutter Ponding?	N/A	N/A	Gutter Slope (%)	N/A
N/A	Gutter Lip Ht (in)	N/A	N/A	Gutter X Slope (%)	N/A
N/A	Painted X Walk1?	No	N/A	Painted X Walk2?	N/A
	X Walk 1 Direction	To NE		X Walk 2 Direction	N/A
N/A	X Walk 1 Width (in)	N/A	N/A	X Walk 2 Width (in)	N/A
	X Walk 1 Slope (%)	4.3		X Walk 2 Slope (%)	N/A
	X Walk 1 X Slope (%)	2.2		X Walk 2 X Slope (%)	N/A

N/A	Ramp inside XWalk1?	N/A	N/A	Ramp inside XWalk2?	N/A
	Road Slope (%)	N/A	N/A	Clear Space?	N/A
	Road X Slope (%)	N/A	N/A	Clear Space to XWalk (in)	N/A
N/A	Any Obstructions?	N/A	N/A	Storm Grate/Utility Hazard?	N/A
	Obstruction Type			Storm Grate/Utility Type	
		N/A			N/A
			Yes	Surface Condition? (G/P)	Good

**Remove & Replace Entire Ramp.**
