Access Compliance Report Public Rights-of-Way (Curb Ramps)

Intersection ID: 17570 Main Street: RANDOLPH RD Cross Street: WOODLARK LN Location: SW Initial Pass/Fail: Fail **Overall Compliance: No Severity Score:** ADA ID: BD7D7B6AEC9F Ramp Type: Perp 8.75

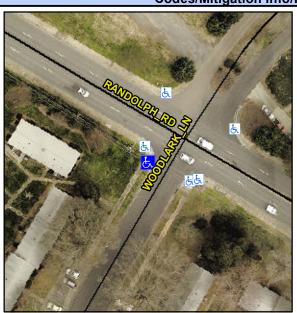
8.0

0.2

Ramp Slope (%)

Ramp XSlope (%)

OSSIDIE SOIULIOII		i leiu ivie
Possible Solutions:	Comp	liance Description
Remove & Replace Entire Ramp.	N/A	Ramp Length (in)
·	No	Ramp Width (in)
	N/A	Flare Type LT
	N/A	Flare Slope LT (%)
	N/A	Flare Traversable LT
	N/A	Landing Length (in)
Surveyor Notes:	N/A	Landing Width (in)
N/A	N/A	Landing Slope (%)
	N/A	Landing X Slope (%
	N/A	Landing Curb? (Y/N
	N/A	Shared Landing?
PROW/ADA:	N/A	Gutter Ponding?
Not Found, R304.5.1	N/A	Gutter Lip Ht (in)
	N/A	Painted X Walk1?
		X Walk 1 Direction
	N/A	X Walk 1 Width (in)
		X Walk 1 Slope (%)
		X Walk 1 X Slope (%
	A1/A	Dames to all NAMelle

Total Cost: 1850.00
