Access Compliance Report

Public Rights-of-Way

(Curb Ramps)

Intersection ID: 24484	Main Street: SAINTFIELD_PL	Cross Street: SWINFORD_PL	Location: SW
ADA ID: BD80E10FBF78	Ramp Type: Perp	Initial Pass/Fail: Fail	Overall Compliance: No
		Severity Score: 8.75

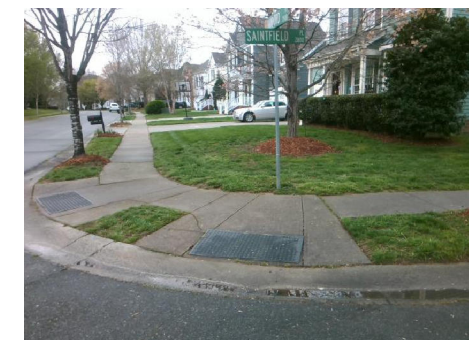
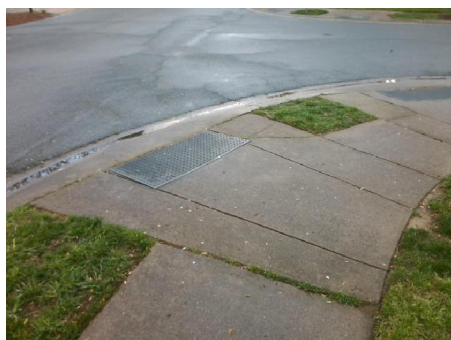
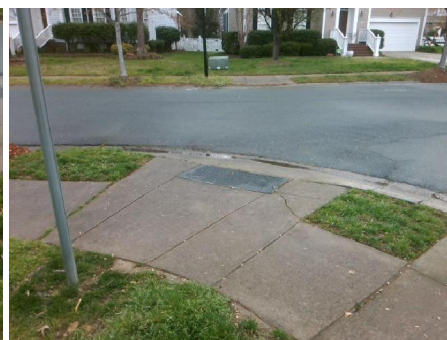
Not Found, R304.5.1

Compliance	Description	Data	Compliance	Description	Data
N/A	Ramp Length (in)	42.0	Yes	Ramp Slope (%)	6.9
No	Ramp Width (in)	41.0	Yes	Ramp XSlope (%)	0.1
N/A	Flare Type LT	N/A	N/A	Flare Type RT	N/A
N/A	Flare Slope LT (%)	N/A	N/A	Flare Slope RT (%)	N/A
N/A	Flare Traversable LT?	N/A	N/A	Flare Traversable RT?	N/A
N/A	Landing Length (in)	N/A	N/A	DWS Provided?	N/A
N/A	Landing Width (in)	N/A	N/A	DWS Contrast?	N/A
N/A	Landing Slope (%)	N/A	N/A	DWS Length (in)	N/A
N/A	Landing X Slope (%)	N/A	N/A	DWS Full Width?	N/A
N/A	Landing Curb? (Y/N)	N/A	N/A	DWS Offset (in)	N/A
N/A	Shared Landing?	N/A			
N/A	Gutter Ponding?	Yes	N/A	Gutter Slope (%)	N/A
N/A	Gutter Lip Ht (in)	N/A	N/A	Gutter X Slope (%)	N/A
N/A	Painted X Walk1?	No	N/A	Painted X Walk2?	N/A
	X Walk 1 Direction	To N		X Walk 2 Direction	N/A
N/A	X Walk 1 Width (in)	N/A	N/A	X Walk 2 Width (in)	N/A
	X Walk 1 Slope (%)	3.7		X Walk 2 Slope (%)	N/A
	X Walk 1 X Slope (%)	2.0		X Walk 2 X Slope (%)	N/A

N/A	Ramp inside XWalk1?	N/A	N/A	Ramp inside XWalk2?	N/A
	Road Slope (%)	N/A	N/A	Clear Space?	N/A
	Road X Slope (%)	N/A	N/A	Clear Space to XWalk (in)	N/A
N/A	Any Obstructions?	N/A	N/A	Storm Grate/Utility Hazard?	N/A
	Obstruction Type			Storm Grate/Utility Type	
		N/A			N/A
		Yes		Surface Condition? (G/P)	Good

Remove & Replace Entire Ramp.
