Intersection ID: 17498	Main Street: BAINBRIDGE_RD	Cross Street: KNICKERBOCKER_DR	Location:	N
ADA ID: BD96AC1CBA33	Ramp Type: PerpDiag	Initial Pass/Fail: Fail	Overall Compliance: No	Severity Score: 13.75

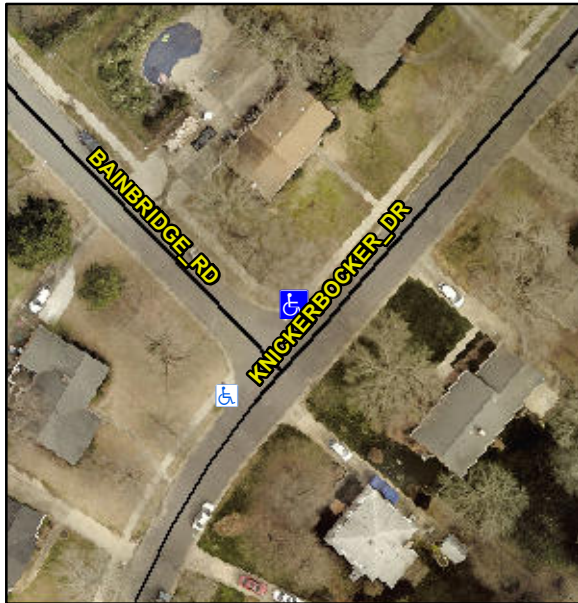
Not Found, R304.2.2, R304.5.3

Compliance	Description	Data	Compliance	Description	Data
N/A	Ramp Length (in)	48.0	No	Ramp Slope (%)	9.9
Yes	Ramp Width (in)	48.0	No	Ramp XSlope (%)	2.5
N/A	Flare Type LT	N/A	N/A	Flare Type RT	N/A
N/A	Flare Slope LT (%)	N/A	N/A	Flare Slope RT (%)	N/A
N/A	Flare Traversable LT?	N/A	N/A	Flare Traversable RT?	N/A
N/A	Landing Length (in)	N/A	N/A	DWS Provided?	N/A
N/A	Landing Width (in)	N/A	N/A	DWS Contrast?	N/A
N/A	Landing Slope (%)	N/A	N/A	DWS Length (in)	N/A
N/A	Landing X Slope (%)	N/A	N/A	DWS Full Width?	N/A
N/A	Landing Curb? (Y/N)	N/A	N/A	DWS Offset (in)	N/A
N/A	Shared Landing?	N/A			
N/A	Gutter Ponding?	N/A	N/A	Gutter Slope (%)	N/A
N/A	Gutter Lip Ht (in)	N/A	N/A	Gutter X Slope (%)	N/A
N/A	Painted X Walk1?	No	N/A	Painted X Walk2?	No
	X Walk 1 Direction	To SW		X Walk 2 Direction	To SE
N/A	X Walk 1 Width (in)	N/A	N/A	X Walk 2 Width (in)	N/A
	X Walk 1 Slope (%)	0.8		X Walk 2 Slope (%)	2.6
	X Walk 1 X Slope (%)	2.3		X Walk 2 X Slope (%)	2.5

N/A	Ramp inside XWalk1?	N/A	N/A	Ramp inside XWalk2?	N/A
	Road Slope (%)	3.3	N/A	Clear Space?	N/A
	Road X Slope (%)	3.1	N/A	Clear Space to XWalk (in)	N/A
N/A	Any Obstructions?	N/A	N/A	Storm Grate/Utility Hazard?	N/A
	Obstruction Type			Storm Grate/Utility Type	
		N/A			N/A
			Yes	Surface Condition? (G/P)	Good

Remove & Replace Curb Ramp With Two New Directional Ramps or Equivalent.

Total Cost: \$ 3200.00
