Access Compliance Report

Public Rights-of-Way

(Curb Ramps)

Intersection ID: 18738	Main Street: FERNCLIFF_RD	Cross Street: SHARON_RD	Location: NW
ADA ID: BD96D0DF6B86	Ramp Type: PerpDiag	Initial Pass/Fail: Fail	Overall Compliance: No
Severity Score: 10			
Codes/Mitigation Info/Possible Solution		Field Measurements/Component Compliance

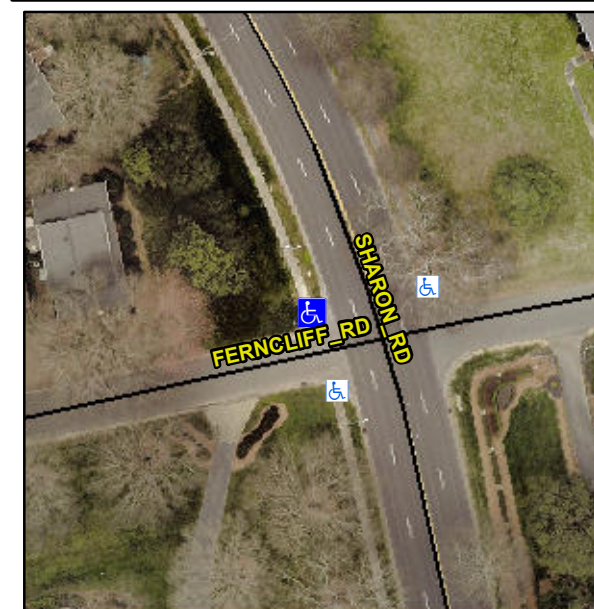
Not Found, R304.5.1, R304.5.3

Compliance	Description	Data	Compliance	Description	Data
N/A	Ramp Length (in)	65.0	Yes	Ramp Slope (%)	7.6
No	Ramp Width (in)	41.0	No	Ramp XSlope (%)	3.3
N/A	Flare Type LT	N/A	N/A	Flare Type RT	N/A
N/A	Flare Slope LT (%)	N/A	N/A	Flare Slope RT (%)	N/A
N/A	Flare Traversable LT?	N/A	N/A	Flare Traversable RT?	N/A
N/A	Landing Length (in)	N/A	N/A	DWS Provided?	N/A
N/A	Landing Width (in)	N/A	N/A	DWS Contrast?	N/A
N/A	Landing Slope (%)	N/A	N/A	DWS Length (in)	N/A
N/A	Landing X Slope (%)	N/A	N/A	DWS Full Width?	N/A
N/A	Landing Curb? (Y/N)	N/A	N/A	DWS Offset (in)	N/A
N/A	Shared Landing?	N/A			
N/A	Gutter Ponding?	N/A	N/A	Gutter Slope (%)	N/A
N/A	Gutter Lip Ht (in)	N/A	N/A	Gutter X Slope (%)	N/A
N/A	Painted X Walk1?	No	N/A	Painted X Walk2?	No
	X Walk 1 Direction	To S		X Walk 2 Direction	To E
N/A	X Walk 1 Width (in)	N/A	N/A	X Walk 2 Width (in)	N/A
	X Walk 1 Slope (%)	3.2		X Walk 2 Slope (%)	2.1
	X Walk 1 X Slope (%)	1.3		X Walk 2 X Slope (%)	2.8

N/A	Ramp inside XWalk1?	N/A	N/A	Ramp inside XWalk2?	N/A
	Road Slope (%)	4.5	N/A	Clear Space?	N/A
	Road X Slope (%)	1.6	N/A	Clear Space to XWalk (in)	N/A
N/A	Any Obstructions?	N/A	N/A	Storm Grate/Utility Hazard?	N/A
	Obstruction Type			Storm Grate/Utility Type	
		N/A			N/A
			Yes	Surface Condition? (G/P)	Good

Remove & Replace Curb Ramp With Two New Directional Ramps or Equivalent.

Total Cost: \$ 3200.00
