Access Compliance Report

Public Rights-of-Way

(Curb Ramps)

Intersection ID: 13539	Main Street: PINTA_CT	Cross Street: TRYSTING_RD	Location: NW
ADA ID: BD9995F227CA	Ramp Type: Perp	Initial Pass/Fail: Fail	Overall Compliance: No
Codes/Mitigation Info/Possible Solution		Field Measurements/Component Compliance	
Severity Score: 21.25

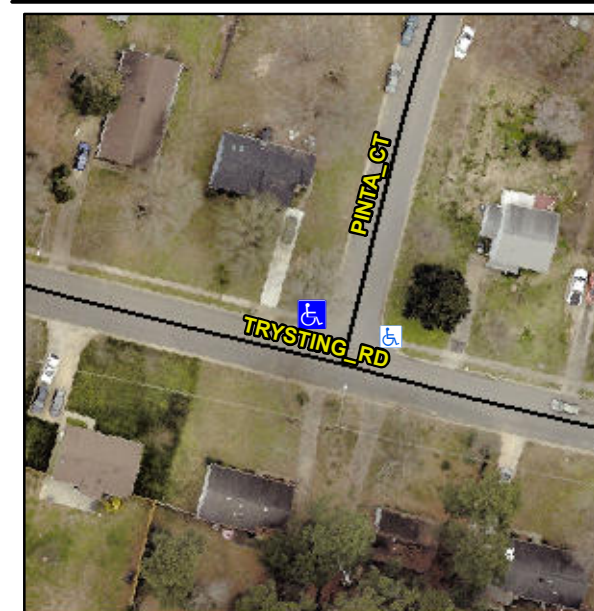
Not Found, R304.5.1, R304.5.3

Compliance	Description	Data	Compliance	Description	Data
N/A	Ramp Length (in)	50.0	Yes	Ramp Slope (%)	6.4
No	Ramp Width (in)	47.0	No	Ramp XSlope (%)	5.1
N/A	Flare Type LT	N/A	N/A	Flare Type RT	N/A
N/A	Flare Slope LT (%)	N/A	N/A	Flare Slope RT (%)	N/A
N/A	Flare Traversable LT?	N/A	N/A	Flare Traversable RT?	N/A
N/A	Landing Length (in)	N/A	N/A	DWS Provided?	N/A
N/A	Landing Width (in)	N/A	N/A	DWS Contrast?	N/A
N/A	Landing Slope (%)	N/A	N/A	DWS Length (in)	N/A
N/A	Landing X Slope (%)	N/A	N/A	DWS Full Width?	N/A
N/A	Landing Curb? (Y/N)	N/A	N/A	DWS Offset (in)	N/A
N/A	Shared Landing?	N/A			
N/A	Gutter Ponding?	N/A	N/A	Gutter Slope (%)	N/A
N/A	Gutter Lip Ht (in)	N/A	N/A	Gutter X Slope (%)	N/A
N/A	Painted X Walk1?	No	N/A	Painted X Walk2?	N/A
	X Walk 1 Direction	To E		X Walk 2 Direction	N/A
N/A	X Walk 1 Width (in)	N/A	N/A	X Walk 2 Width (in)	N/A
	X Walk 1 Slope (%)	0.6		X Walk 2 Slope (%)	N/A
	X Walk 1 X Slope (%)	2.8		X Walk 2 X Slope (%)	N/A

N/A	Ramp inside XWalk1?	N/A	N/A	Ramp inside XWalk2?	N/A
	Road Slope (%)	N/A	N/A	Clear Space?	N/A
	Road X Slope (%)	N/A	N/A	Clear Space to XWalk (in)	N/A
N/A	Any Obstructions?	N/A	N/A	Storm Grate/Utility Hazard?	N/A
	Obstruction Type			Storm Grate/Utility Type	
		N/A			N/A
			Yes	Surface Condition? (G/P)	Good

Possible Solutions:

Remove & Replace Entire Ramp.
