# Access Compliance Report

## Public Rights-of-Way

### (Curb Ramps)

Intersection ID: 31416	Main Street: BRAWER_FARM_DR	Cross Street: IRON_BRIGADE_LN	Location: E
ADA ID: BD99970B2391	Ramp Type: PerpDiag	Initial Pass/Fail: Fail	Overall Compliance: No
		Severity Score: 22.5

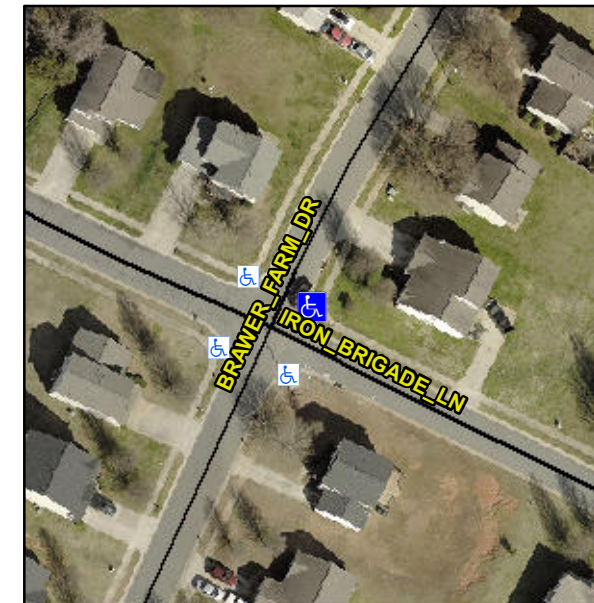
**Not Found, R304.5.1, R304.2.2, R304.5.3**

Compliance	Description	Data	Compliance	Description	Data
N/A	Ramp Length (in)	48.0	No	Ramp Slope (%)	8.5
No	Ramp Width (in)	46.0	No	Ramp XSlope (%)	4.7
N/A	Flare Type LT	N/A	N/A	Flare Type RT	N/A
N/A	Flare Slope LT (%)	N/A	N/A	Flare Slope RT (%)	N/A
N/A	Flare Traversable LT?	N/A	N/A	Flare Traversable RT?	N/A
N/A	Landing Length (in)	N/A	N/A	DWS Provided?	N/A
N/A	Landing Width (in)	N/A	N/A	DWS Contrast?	N/A
N/A	Landing Slope (%)	N/A	N/A	DWS Length (in)	N/A
N/A	Landing X Slope (%)	N/A	N/A	DWS Full Width?	N/A
N/A	Landing Curb? (Y/N)	N/A	N/A	DWS Offset (in)	N/A
N/A	Shared Landing?	N/A			
N/A	Gutter Ponding?	N/A	N/A	Gutter Slope (%)	N/A
N/A	Gutter Lip Ht (in)	0.5	N/A	Gutter X Slope (%)	N/A
N/A	Painted X Walk1?	No	N/A	Painted X Walk2?	No
	X Walk 1 Direction	To N		X Walk 2 Direction	To S
N/A	X Walk 1 Width (in)	N/A	N/A	X Walk 2 Width (in)	N/A
	X Walk 1 Slope (%)	0.6		X Walk 2 Slope (%)	1.6
	X Walk 1 X Slope (%)	3.0		X Walk 2 X Slope (%)	2.3

N/A	Ramp inside XWalk1?	N/A	N/A	Ramp inside XWalk2?	N/A
	Road Slope (%)	3.3	N/A	Clear Space?	N/A
	Road X Slope (%)	0.2	N/A	Clear Space to XWalk (in)	N/A
N/A	Any Obstructions?	N/A	N/A	Storm Grate/Utility Hazard?	N/A
	Obstruction Type			Storm Grate/Utility Type	
		N/A			N/A
			Yes	Surface Condition? (G/P)	Good

**Remove & Replace Curb Ramp With Two New Directional Ramps or Equivalent.**
