# Access Compliance Report

## Public Rights-of-Way

### (Curb Ramps)

Intersection ID: 44910	Main Street: FOX_POINT_DR	Cross Street: OAKBURN_DR	Location:	N
ADA ID: BD9AC547574C	Ramp Type: PerpDiag	Initial Pass/Fail: Fail	Overall Compliance: No	Severity Score: 17.5
Codes/Mitigation Info/Possible Solution		Field Measurements/Component Compliance

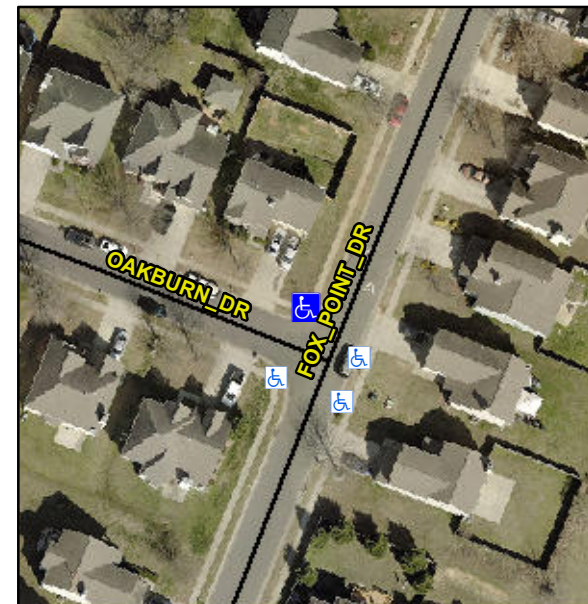
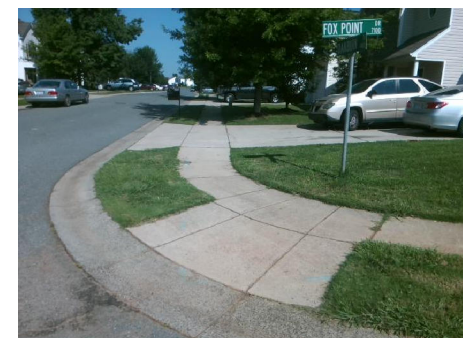
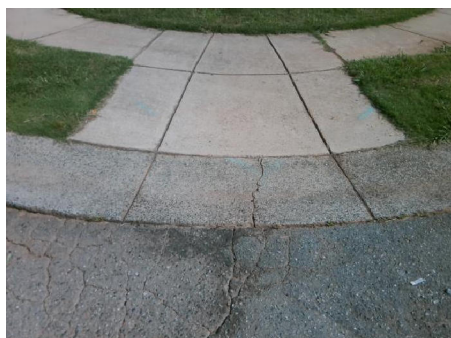
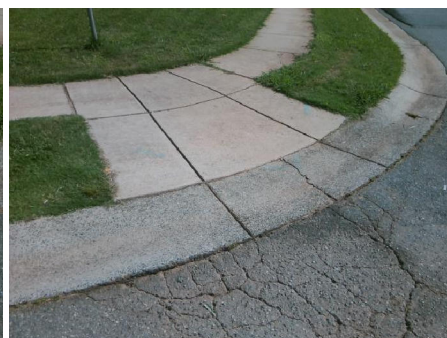
Compliance	Description	Data	Compliance	Description	Data
N/A	Ramp Length (in)	47.5	Yes	Ramp Slope (%)	7.8
No	Ramp Width (in)	35.0	Yes	Ramp XSlope (%)	0.5
N/A	Flare Type LT	N/A	N/A	Flare Type RT	N/A
N/A	Flare Slope LT (%)	N/A	N/A	Flare Slope RT (%)	N/A
N/A	Flare Traversable LT?	N/A	N/A	Flare Traversable RT?	N/A
N/A	Landing Length (in)	N/A	N/A	DWS Provided?	N/A
N/A	Landing Width (in)	N/A	N/A	DWS Contrast?	N/A
N/A	Landing Slope (%)	N/A	N/A	DWS Length (in)	N/A
N/A	Landing X Slope (%)	N/A	N/A	DWS Full Width?	N/A
N/A	Landing Curb? (Y/N)	N/A	N/A	DWS Offset (in)	N/A
N/A	Shared Landing?	N/A			
N/A	Gutter Ponding?	N/A	N/A	Gutter Slope (%)	N/A
N/A	Gutter Lip Ht (in)	N/A	N/A	Gutter X Slope (%)	N/A
N/A	Painted X Walk1?	No	N/A	Painted X Walk2?	No
	X Walk 1 Direction	To SW		X Walk 2 Direction	To SE
N/A	X Walk 1 Width (in)	N/A	N/A	X Walk 2 Width (in)	N/A
	X Walk 1 Slope (%)	1.6		X Walk 2 Slope (%)	0.9
	X Walk 1 X Slope (%)	0.1		X Walk 2 X Slope (%)	1.6

N/A	Ramp inside XWalk1?	N/A	N/A	Ramp inside XWalk2?	N/A
	Road Slope (%)	1.1	N/A	Clear Space?	N/A
	Road X Slope (%)	0.8	N/A	Clear Space to XWalk (in)	N/A
N/A	Any Obstructions?	N/A	N/A	Storm Grate/Utility Hazard?	N/A
	Obstruction Type			Storm Grate/Utility Type	
		N/A			N/A
			Yes	Surface Condition? (G/P)	Good

Possible Solutions:

**Remove & Replace Curb Ramp With Two New Directional Ramps or Equivalent.**

**R304.5.1**
