Access Compliance Report

Public Rights-of-Way

(Curb Ramps)

Intersection ID: 27538	Main Street: ALTON_FARM_LN	Cross Street: CHARLOTTE_VIEW_DR	Location: S
ADA ID: BD9DA494CC06	Ramp Type: PerpDiag	Initial Pass/Fail: Fail	Overall Compliance: No
Severity Score: 22.5			
Codes/Mitigation Info/Possible Solution		Field Measurements/Component Compliance

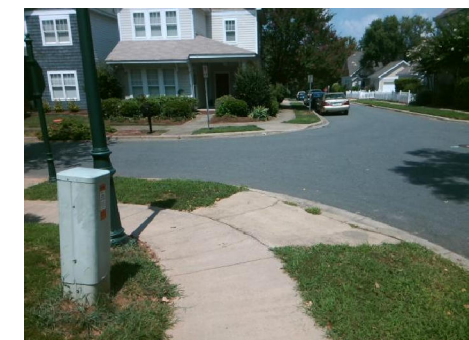
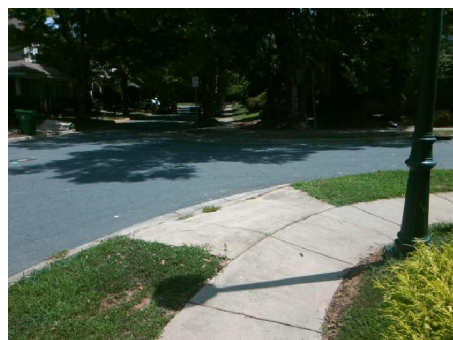
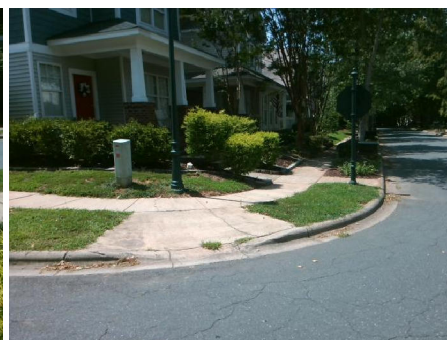
Not Found, R304.5.1, R304.2.2, R304.5.3

Compliance	Description	Data	Compliance	Description	Data
N/A	Ramp Length (in)	58.0	No	Ramp Slope (%)	10.5
No	Ramp Width (in)	36.0	No	Ramp XSlope (%)	4.9
N/A	Flare Type LT	N/A	N/A	Flare Type RT	N/A
N/A	Flare Slope LT (%)	N/A	N/A	Flare Slope RT (%)	N/A
N/A	Flare Traversable LT?	N/A	N/A	Flare Traversable RT?	N/A
N/A	Landing Length (in)	N/A	N/A	DWS Provided?	N/A
N/A	Landing Width (in)	N/A	N/A	DWS Contrast?	N/A
N/A	Landing Slope (%)	N/A	N/A	DWS Length (in)	N/A
N/A	Landing X Slope (%)	N/A	N/A	DWS Full Width?	N/A
N/A	Landing Curb? (Y/N)	N/A	N/A	DWS Offset (in)	N/A
N/A	Shared Landing?	N/A			
N/A	Gutter Ponding?	N/A	N/A	Gutter Slope (%)	N/A
N/A	Gutter Lip Ht (in)	N/A	N/A	Gutter X Slope (%)	N/A
N/A	Painted X Walk1?	No	N/A	Painted X Walk2?	No
	X Walk 1 Direction	To NE		X Walk 2 Direction	To N
N/A	X Walk 1 Width (in)	N/A	N/A	X Walk 2 Width (in)	N/A
	X Walk 1 Slope (%)	5.0		X Walk 2 Slope (%)	1.6
	X Walk 1 X Slope (%)	4.7		X Walk 2 X Slope (%)	3.9

N/A	Ramp inside XWalk1?	N/A	N/A	Ramp inside XWalk2?	N/A
	Road Slope (%)	5.1	N/A	Clear Space?	N/A
	Road X Slope (%)	0.6	N/A	Clear Space to XWalk (in)	N/A
N/A	Any Obstructions?	N/A	N/A	Storm Grate/Utility Hazard?	N/A
	Obstruction Type			Storm Grate/Utility Type	
		N/A			N/A
			Yes	Surface Condition? (G/P)	Good

Remove & Replace Curb Ramp With Two New Directional Ramps or Equivalent.
