# Access Compliance Report

## Public Rights-of-Way

### (Curb Ramps)

Intersection ID: 10032503	Main Street: N_CALDWELL_ST	Cross Street: N/A	Location: N
ADA ID: BDAC354631BC	Ramp Type: Perp	Initial Pass/Fail: Fail	Overall Compliance: No
Severity Score: 25			
Codes/Mitigation Info/Possible Solution		Field Measurements/Component Compliance

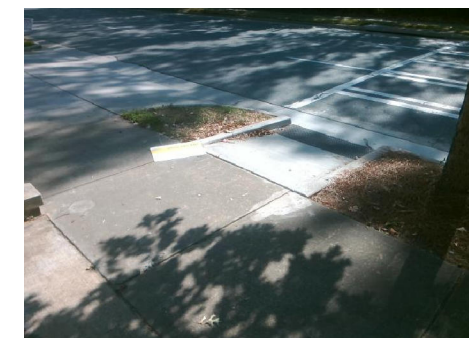
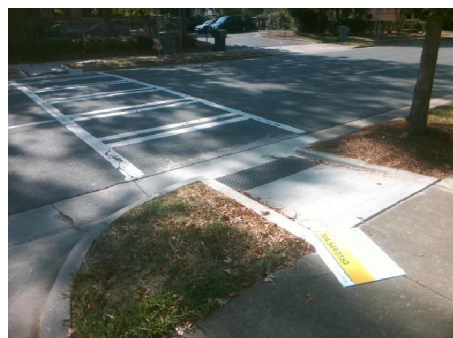
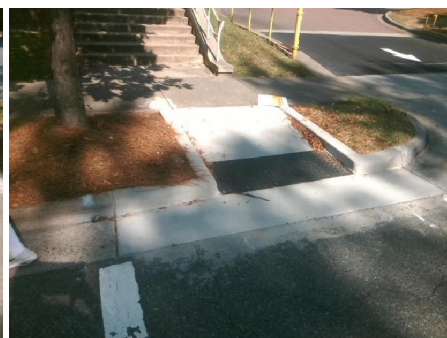
**Not Found, R304.2.2**

Compliance	Description	Data	Compliance	Description	Data
N/A	Ramp Length (in)	71.0	No	Ramp Slope (%)	13.5
Yes	Ramp Width (in)	62.0	Yes	Ramp XSlope (%)	0.9
N/A	Flare Type LT	N/A	N/A	Flare Type RT	N/A
N/A	Flare Slope LT (%)	N/A	N/A	Flare Slope RT (%)	N/A
N/A	Flare Traversable LT?	N/A	N/A	Flare Traversable RT?	N/A
N/A	Landing Length (in)	N/A	N/A	DWS Provided?	N/A
N/A	Landing Width (in)	N/A	N/A	DWS Contrast?	N/A
N/A	Landing Slope (%)	N/A	N/A	DWS Length (in)	N/A
N/A	Landing X Slope (%)	N/A	N/A	DWS Full Width?	N/A
N/A	Landing Curb? (Y/N)	N/A	N/A	DWS Offset (in)	N/A
N/A	Shared Landing?	N/A			
N/A	Gutter Ponding?	N/A	N/A	Gutter Slope (%)	N/A
N/A	Gutter Lip Ht (in)	N/A	N/A	Gutter X Slope (%)	N/A
N/A	Painted X Walk1?	Yes	N/A	Painted X Walk2?	N/A
	X Walk 1 Direction	To SE		X Walk 2 Direction	N/A
N/A	X Walk 1 Width (in)	111.0	N/A	X Walk 2 Width (in)	N/A
	X Walk 1 Slope (%)	2.3		X Walk 2 Slope (%)	N/A
	X Walk 1 X Slope (%)	1.4		X Walk 2 X Slope (%)	N/A

N/A	Ramp inside XWalk1?	Yes	N/A	Ramp inside XWalk2?	N/A
	Road Slope (%)	N/A	N/A	Clear Space?	N/A
	Road X Slope (%)	N/A	N/A	Clear Space to XWalk (in)	N/A
N/A	Any Obstructions?	N/A	N/A	Storm Grate/Utility Hazard?	N/A
	Obstruction Type			Storm Grate/Utility Type	
		N/A			N/A
			Yes	Surface Condition? (G/P)	Good

**Remove & Replace Entire Ramp.**
