# Access Compliance Report

## Public Rights-of-Way

### (Curb Ramps)

Intersection ID: 53624	Main Street: PROSPERITY RIDGE RD	Cross Street: RIDGE RD	Location: SE
ADA ID: BDADE820E2AF	Ramp Type: Perp	Initial Pass/Fail: Fail	Overall Compliance: No
Severity Score: 25			
Codes/Mitigation Info/Possible Solution		Field Measurements/Component Compliance

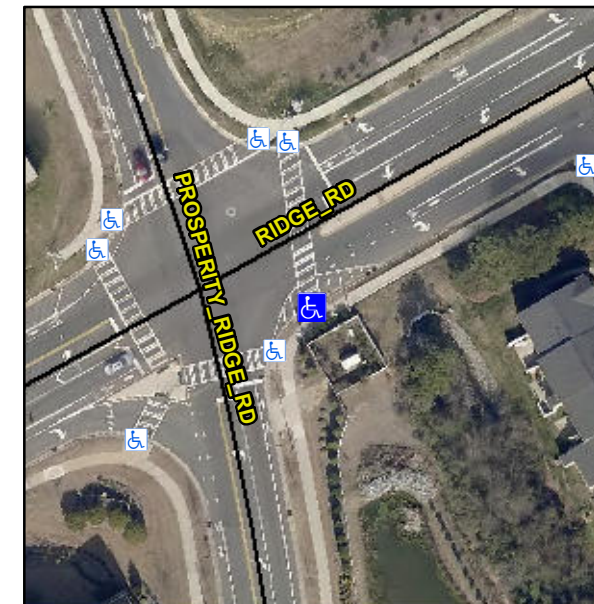
Compliance	Description	Data	Compliance	Description	Data
N/A	Ramp Length (in)	38.0	No	Ramp Slope (%)	14.9
Yes	Ramp Width (in)	48.0	Yes	Ramp XSlope (%)	1.8
N/A	Flare Type LT	N/A	N/A	Flare Type RT	N/A
N/A	Flare Slope LT (%)	N/A	N/A	Flare Slope RT (%)	N/A
N/A	Flare Traversable LT?	N/A	N/A	Flare Traversable RT?	N/A
N/A	Landing Length (in)	N/A	N/A	DWS Provided?	N/A
N/A	Landing Width (in)	N/A	N/A	DWS Contrast?	N/A
N/A	Landing Slope (%)	N/A	N/A	DWS Length (in)	N/A
N/A	Landing X Slope (%)	N/A	N/A	DWS Full Width?	N/A
N/A	Landing Curb? (Y/N)	N/A	N/A	DWS Offset (in)	N/A
N/A	Shared Landing?	N/A			
N/A	Gutter Ponding?	N/A	N/A	Gutter Slope (%)	N/A
N/A	Gutter Lip Ht (in)	N/A	N/A	Gutter X Slope (%)	N/A
N/A	Painted X Walk1?	Yes	N/A	Painted X Walk2?	N/A
	X Walk 1 Direction	To N		X Walk 2 Direction	N/A
N/A	X Walk 1 Width (in)	120.5	N/A	X Walk 2 Width (in)	N/A
	X Walk 1 Slope (%)	1.4		X Walk 2 Slope (%)	N/A
	X Walk 1 X Slope (%)	1.8		X Walk 2 X Slope (%)	N/A

N/A	Ramp inside XWalk1?	Yes	N/A	Ramp inside XWalk2?	N/A
	Road Slope (%)	N/A	N/A	Clear Space?	N/A
	Road X Slope (%)	N/A	N/A	Clear Space to XWalk (in)	N/A
N/A	Any Obstructions?	N/A	N/A	Storm Grate/Utility Hazard?	N/A
	Obstruction Type			Storm Grate/Utility Type	
		N/A			N/A
		Yes		Surface Condition? (G/P)	Good

Possible Solutions:

**Remove & Replace Entire Ramp.**

**R304.2.2**

**\$ 1850.00**
