# Access Compliance Report

## Public Rights-of-Way

| Intersection ID: 45834 | Main Street: PATRICIA_ANN_LN | Cross Street: KELDEN_WALKER_LN | Location: SE |
| ADA ID: BDAE1FE75221 | Ramp Type: PerpDiag | Initial Pass/Fail: Fail | Overall Compliance: No |

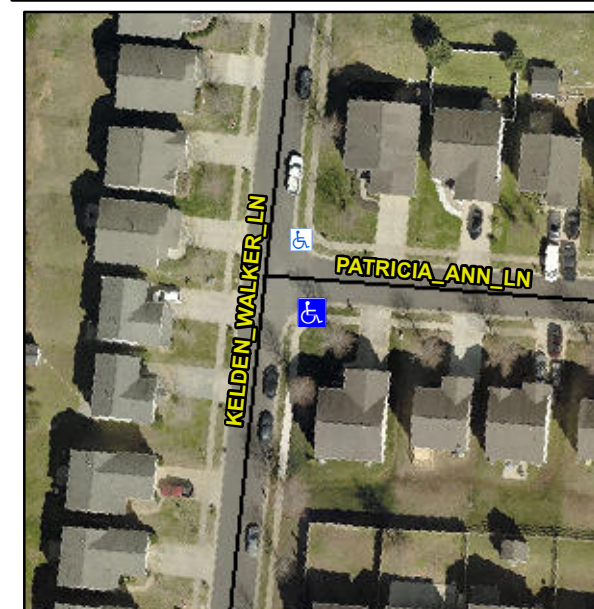
**Not Found, R304.5.1, R304.2.2, R304.5.3**

| Compliance | Description | Data | Compliance | Description | Data |
|---|---|---|---|---|---|
| N/A | Ramp Length (in) | 47.5 | No | Ramp Slope (%) | 9.2 |
| No | Ramp Width (in) | 37.0 | No | Ramp XSlope (%) | 3.9 |

**Remove & Replace Curb Ramp With Two New Directional Ramps or Equivalent.**
