Access Compliance Report Public Rights-of-Way (Curb Ramps)

Intersection ID: 12445 Main Street: CHESTNUT_AV Cross Street: THE_PLAZA Location: NE **Overall Compliance: No** ADA ID: BDB6EF0D4DCD Ramp Type: Directional1 Initial Pass/Fail: Fail **Severity Score:** 12.5

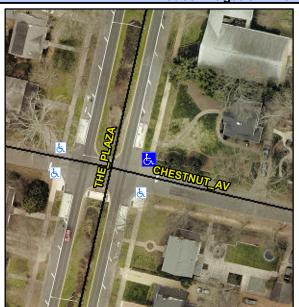
•	Yes Ramp Width (in)		65.0	N/A	Grade	Break Slope (%)	0.0	
		No	Ramp Slope (%)	9.1	N/A	Grade	Break XSlope (%)	0.0	
			Yes	Ramp XSlope (%)	0.9				
			N/A	Flare Type LT	N/A	N/A	Flare ⁻	Гуре RT	N/A
			N/A	Flare Slope LT (%)	N/A	N/A	Flare	Slope RT (%)	0.0
Surveyor Notes:			N/A	Flare Traversable LT?	N/A	N/A	Flare ⁻	Traversable RT?	N/A
N/A			N/A	Landing Length (in)	0.0	N/A	DWS	Provided?	N/A
			N/A	Landing Width (in)	0.0	N/A	DWS	Contrast?	N/A
			N/A	Landing Slope (%)	0.0	N/A	DWS	Length (in)	N/A
			N/A	Landing X Slope (%)	0.0	N/A	DWS	Full Width?	N/A
PROW/ADA:			N/A	Landing Curb? (Y/N)	N/A	N/A	DWS	Offset LT (in)	N/A
R304.2.2			N/A	Shared Landing?	N/A	N/A	DWS	Offset RT (in)	N/A
			N/A	Gutter Ponding?	0.0 N/A	N/A	Gutter Slope (%)		N/A
			N/A	Gutter Lip Ht (in)	0.5	N/A	Gutter	X Slope (%)	N/A
			N/A	Painted X Walk1?	No		Road	Slope (%)	2.4
				X Walk 1 Direction	To S		Road 2	X Slope (%)	3.3
				X Walk 1 Width (in)	N/A	l	Clear	Space?	N/A

X Walk 1 Slope (%)	2.4	N/A	Clear	Space to XWalk (in)	N/A
				X Walk 1 X Slope (%)	3.3	N/A	Storm	Grate/Utility Hazard?	N/A
			N/A	Ramp inside XWalk1?	N/A		Storm	Grate/Utility Type	
			N/A	Any Obstructions?	N/A				N/A
Total Cost:	\$	1600.00		Obstruction Type		Yes	Surfac	e Condition? (G/P)	Good
					N/A	N/A	Curb S	Slope (%)	4.7

Possible Solution			Field Measurements/Component Compliance						
Possible Solutions:			Compliance Description			Compliance Description Data			
Remove & Replace Entire Ramp.	Ram	ıp.	N/A	Ramp Length (in)	48.0	N/A	Grade	Break?	N/A
