# Access Compliance Report

## Public Rights-of-Way

### (Curb Ramps)

Intersection ID: 27418	Main Street: BALLANTYNE COMMONS PY	Cross Street: BALLANTYNE TRACE CT	Location: NW
ADA ID: BDBA16ACBED4	Ramp Type: Perp	Initial Pass/Fail: Fail	Overall Compliance: No
Severity Score: 12.5			
Codes/Mitigation Info/Possible Solution		Field Measurements/Component Compliance

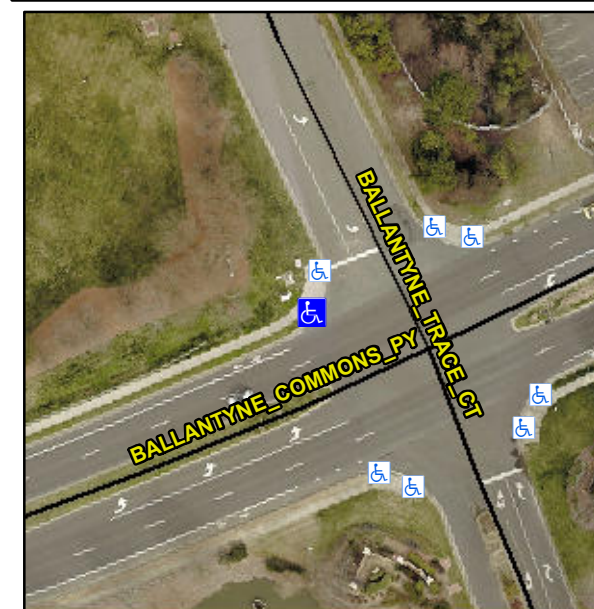
**Not Found, R304.2.2**

Compliance	Description	Data	Compliance	Description	Data
N/A	Ramp Length (in)	108.0	No	Ramp Slope (%)	8.4
Yes	Ramp Width (in)	48.0	Yes	Ramp XSlope (%)	2.0
N/A	Flare Type LT	N/A	N/A	Flare Type RT	N/A
N/A	Flare Slope LT (%)	N/A	N/A	Flare Slope RT (%)	N/A
N/A	Flare Traversable LT?	N/A	N/A	Flare Traversable RT?	N/A
N/A	Landing Length (in)	N/A	N/A	DWS Provided?	N/A
N/A	Landing Width (in)	N/A	N/A	DWS Contrast?	N/A
N/A	Landing Slope (%)	N/A	N/A	DWS Length (in)	N/A
N/A	Landing X Slope (%)	N/A	N/A	DWS Full Width?	N/A
N/A	Landing Curb? (Y/N)	N/A	N/A	DWS Offset (in)	N/A
N/A	Shared Landing?	N/A			
N/A	Gutter Ponding?	N/A	N/A	Gutter Slope (%)	N/A
N/A	Gutter Lip Ht (in)	N/A	N/A	Gutter X Slope (%)	N/A
N/A	Painted X Walk1?	No	N/A	Painted X Walk2?	N/A
	X Walk 1 Direction	To S		X Walk 2 Direction	N/A
N/A	X Walk 1 Width (in)	N/A	N/A	X Walk 2 Width (in)	N/A
	X Walk 1 Slope (%)	8.9		X Walk 2 Slope (%)	N/A
	X Walk 1 X Slope (%)	4.0		X Walk 2 X Slope (%)	N/A

N/A	Ramp inside XWalk1?	N/A	N/A	Ramp inside XWalk2?	N/A
	Road Slope (%)	N/A	N/A	Clear Space?	N/A
	Road X Slope (%)	N/A	N/A	Clear Space to XWalk (in)	N/A
N/A	Any Obstructions?	N/A	N/A	Storm Grate/Utility Hazard?	N/A
	Obstruction Type			Storm Grate/Utility Type	
		N/A			N/A
			Yes	Surface Condition? (G/P)	Good

**Remove & Replace Entire Ramp.**

Total Cost: \$ 1850.00
