# Access Compliance Report

## Public Rights-of-Way

### (Curb Ramps)

Intersection ID: 8813	Main Street: JENNINGS_ST	Cross Street: N/A	Location:	N
ADA ID: BDBC365D6002	Ramp Type: Perp	Initial Pass/Fail: Fail	Overall Compliance: No	Severity Score: 1.25
Codes/Mitigation Info/Possible Solution		Field Measurements/Component Compliance

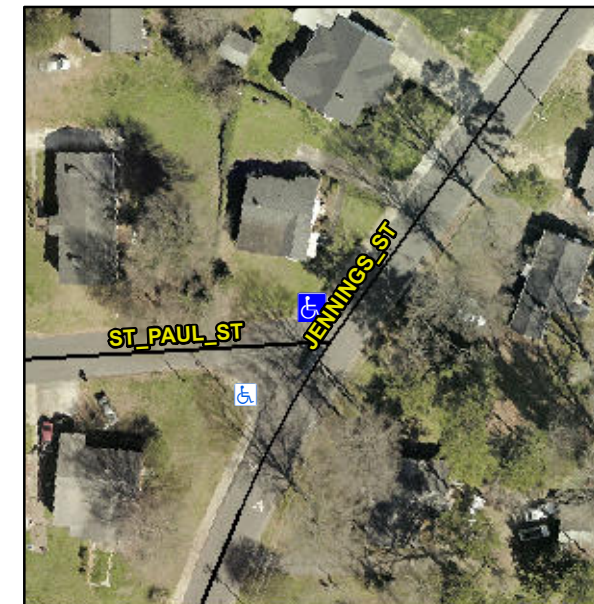
**Not Found, R304.5.3**

Compliance	Description	Data	Compliance	Description	Data
N/A	Ramp Length (in)	61.0	Yes	Ramp Slope (%)	7.4
Yes	Ramp Width (in)	84.0	No	Ramp XSlope (%)	4.7
N/A	Flare Type LT	N/A	N/A	Flare Type RT	N/A
N/A	Flare Slope LT (%)	N/A	N/A	Flare Slope RT (%)	N/A
N/A	Flare Traversable LT?	N/A	N/A	Flare Traversable RT?	N/A
N/A	Landing Length (in)	N/A	N/A	DWS Provided?	N/A
N/A	Landing Width (in)	N/A	N/A	DWS Contrast?	N/A
N/A	Landing Slope (%)	N/A	N/A	DWS Length (in)	N/A
N/A	Landing X Slope (%)	N/A	N/A	DWS Full Width?	N/A
N/A	Landing Curb? (Y/N)	N/A	N/A	DWS Offset (in)	N/A
N/A	Shared Landing?	N/A			
N/A	Gutter Ponding?	N/A	N/A	Gutter Slope (%)	N/A
N/A	Gutter Lip Ht (in)	N/A	N/A	Gutter X Slope (%)	N/A
N/A	Painted X Walk1?	No	N/A	Painted X Walk2?	N/A
	X Walk 1 Direction	To SW		X Walk 2 Direction	N/A
N/A	X Walk 1 Width (in)	N/A	N/A	X Walk 2 Width (in)	N/A
	X Walk 1 Slope (%)	3.2		X Walk 2 Slope (%)	N/A
	X Walk 1 X Slope (%)	4.2		X Walk 2 X Slope (%)	N/A

N/A	Ramp inside XWalk1?	N/A	N/A	Ramp inside XWalk2?	N/A
	Road Slope (%)	N/A	N/A	Clear Space?	N/A
	Road X Slope (%)	N/A	N/A	Clear Space to XWalk (in)	N/A
N/A	Any Obstructions?	N/A	N/A	Storm Grate/Utility Hazard?	N/A
	Obstruction Type			Storm Grate/Utility Type	
		N/A			N/A
			Yes	Surface Condition? (G/P)	Good

Possible Solutions:

**Remove & Replace Entire Ramp.**

Total Cost: \$ 1850.00
