# Access Compliance Report

## Public Rights-of-Way

### (Curb Ramps)

Intersection ID: 16419	Main Street: LANTANA_AV	Cross Street: N_SHARON_AMITY_RD	Location: W
ADA ID: BDE116C0ABCE	Ramp Type: ParaDiag	Initial Pass/Fail: Fail	Overall Compliance: No
Severity Score: 13.75			
Codes/Mitigation Info/Possible Solution		Field Measurements/Component Compliance

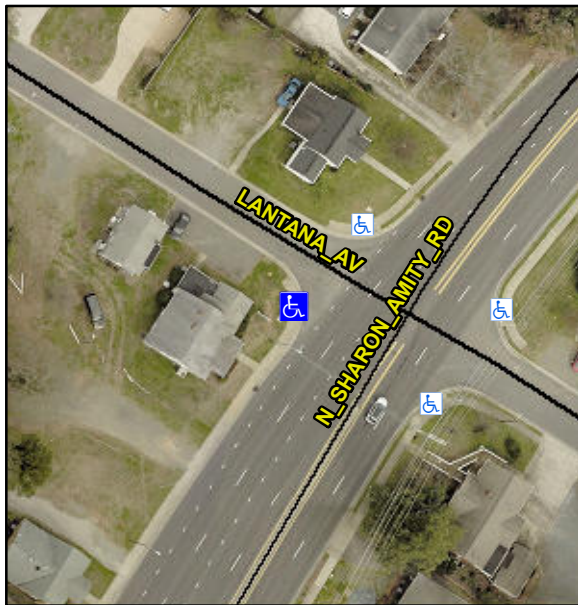
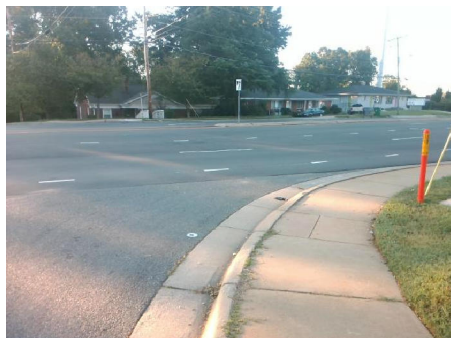
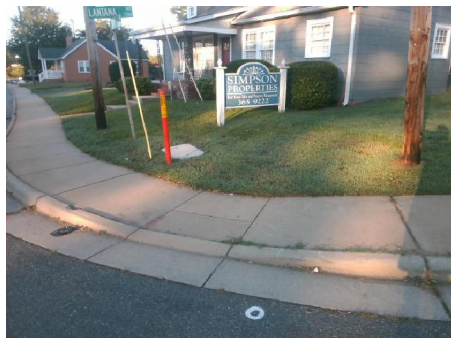
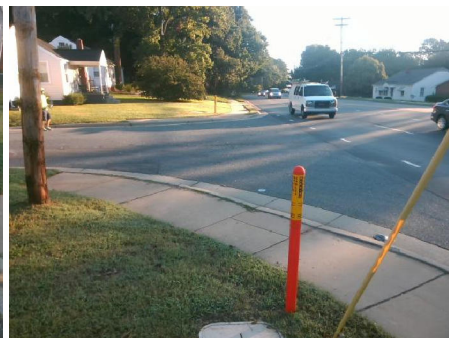
**LT RP < 5%**

Compliance	Description	Data	Compliance	Description	Data
N/A	Ramp Length LT (in)	61.0	N/A	Ramp Length RT (in)	63.0
Yes	Ramp Width LT (in)	60.0	Yes	Ramp Width RT (in)	60.0
Yes	Ramp Slope LT (%)	4.8	No	Ramp Slope RT (%)	9.3
No	Ramp XSlope LT (%)	2.7	No	Ramp XSlope RT (%)	3.1
N/A	Landing Length (in)	N/A	N/A	DWS Provided?	N/A
N/A	Landing Width (in)	N/A	N/A	DWS Contrast?	N/A
N/A	Landing Slope (%)	N/A	N/A	DWS Length (in)	N/A
N/A	Landing X Slope (%)	N/A	N/A	DWS Full Width?	N/A
N/A	Landing Curb? (Y/N)	N/A	N/A	DWS Offset (in)	N/A
N/A	Shared Landing?	N/A			
N/A	Gutter Ponding?	N/A	N/A	Gutter Slope (%)	N/A
N/A	Gutter Lip Ht (in)	N/A	N/A	Gutter X Slope (%)	N/A
N/A	Painted X Walk1?	No	N/A	Painted X Walk2?	No
	X Walk 1 Direction	To SE		X Walk 2 Direction	To NE
N/A	X Walk 1 Width (in)	N/A	N/A	X Walk 2 Width (in)	N/A
	X Walk 1 Slope (%)	2.3		X Walk 2 Slope (%)	2.4
	X Walk 1 X Slope (%)	1.0		X Walk 2 X Slope (%)	2.1
N/A	Ramp inside XWalk1?	N/A	N/A	Ramp inside XWalk2?	N/A

Road Slope (%)	4.0	N/A	Clear Space?	N/A
	Road X Slope (%)	2.0	N/A	Clear Space to XWalk (in)	N/A
N/A	Any Obstructions?	N/A	N/A	Storm Grate/Utility Hazard?	N/A
	Obstruction Type			Storm Grate/Utility Type	
		N/A			N/A
			Yes	Surface Condition? (G/P)	Good
			N/A	Curb Slope (%)	16.5

**Remove & Replace Curb Ramp With Two New Directional Ramps or Equivalent.**

**R304.5.3, R304.3.2**
