Access Compliance Report

Public Rights-of-Way

(Curb Ramps)

Intersection ID: 20383	Main Street: CLEMATIS_DR	Cross Street: ARBOR_WAY	Location: SE
ADA ID: BDE1E144E924	Ramp Type: Perp	Initial Pass/Fail: Fail	Overall Compliance: No
Severity Score: 33.75			
Codes/Mitigation Info/Possible Solution		Field Measurements/Component Compliance

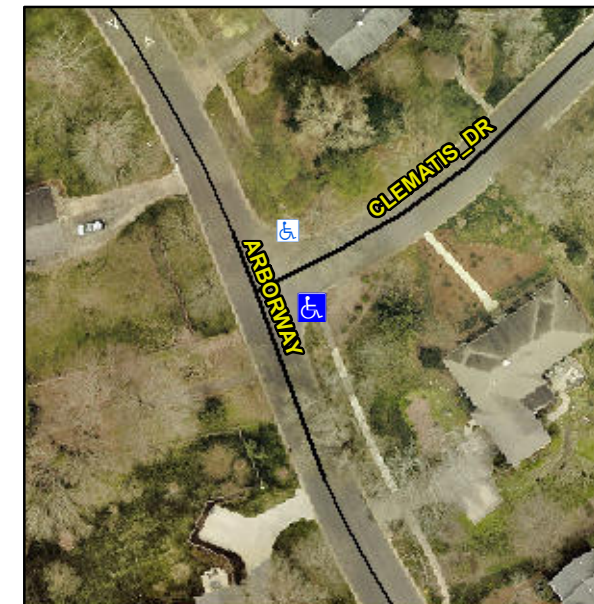
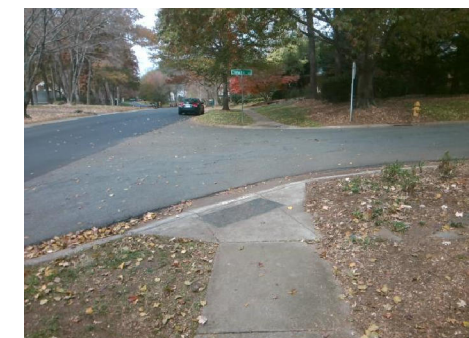
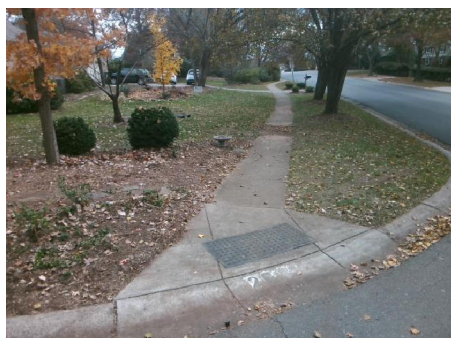
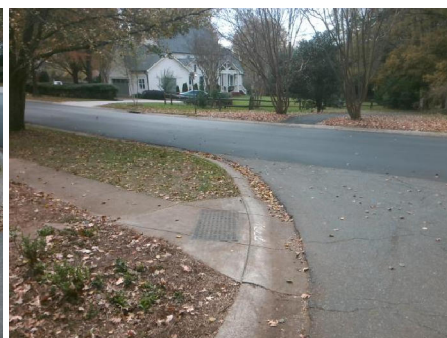
Not Found, R304.5.1, R304.5.3

Compliance	Description	Data	Compliance	Description	Data
N/A	Ramp Length (in)	60.0	Yes	Ramp Slope (%)	3.5
No	Ramp Width (in)	45.0	No	Ramp XSlope (%)	8.3
N/A	Flare Type LT	N/A	N/A	Flare Type RT	N/A
N/A	Flare Slope LT (%)	N/A	N/A	Flare Slope RT (%)	N/A
N/A	Flare Traversable LT?	N/A	N/A	Flare Traversable RT?	N/A
N/A	Landing Length (in)	N/A	N/A	DWS Provided?	N/A
N/A	Landing Width (in)	N/A	N/A	DWS Contrast?	N/A
N/A	Landing Slope (%)	N/A	N/A	DWS Length (in)	N/A
N/A	Landing X Slope (%)	N/A	N/A	DWS Full Width?	N/A
N/A	Landing Curb? (Y/N)	N/A	N/A	DWS Offset (in)	N/A
N/A	Shared Landing?	N/A			
N/A	Gutter Ponding?	N/A	N/A	Gutter Slope (%)	N/A
N/A	Gutter Lip Ht (in)	N/A	N/A	Gutter X Slope (%)	N/A
N/A	Painted X Walk1?	No	N/A	Painted X Walk2?	N/A
	X Walk 1 Direction	To NW		X Walk 2 Direction	N/A
N/A	X Walk 1 Width (in)	N/A	N/A	X Walk 2 Width (in)	N/A
	X Walk 1 Slope (%)	5.6		X Walk 2 Slope (%)	N/A
	X Walk 1 X Slope (%)	3.5		X Walk 2 X Slope (%)	N/A

N/A	Ramp inside XWalk1?	N/A	N/A	Ramp inside XWalk2?	N/A
	Road Slope (%)	N/A	N/A	Clear Space?	N/A
	Road X Slope (%)	N/A	N/A	Clear Space to XWalk (in)	N/A
N/A	Any Obstructions?	N/A	N/A	Storm Grate/Utility Hazard?	N/A
	Obstruction Type			Storm Grate/Utility Type	
		N/A			N/A
			Yes	Surface Condition? (G/P)	Good

Remove & Replace Entire Ramp.
